Orcas Island Health Clinic

Heating, Ventilating, and Air Conditioning System Review and Recommendations Report

7 Deye Lane
Eastsound, WA 98245

18 June, 2019

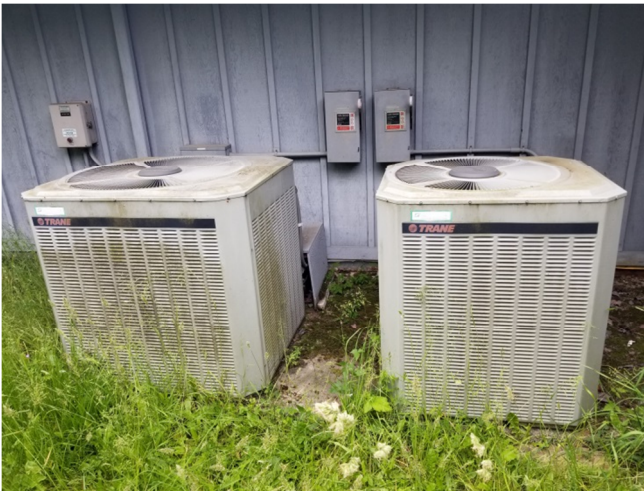
Outdoor Heat Pumps (HPs)

The HVAC for the building is currently provided by four indoor Air Handlers (AHs) located in the attic and four corresponding split Heat Pump condensing units (HPs) located at grade outside. The equipment was manufactured by Trane and is original to the building. The AHs in the attic are hung from structure with vibration isolation hangers. Each AH unit is comprised of a constant volume supply fan, direct expansion (DX) cooling/heating coil, supplemental electric heater, filters, and mixing box. Refrigerant piping is routed to connect the AH and HP units. A thermostat is provided for each AH and located in interior corridors or open space. The thermostats are not lockable and the controls are accessible by the occupants. The thermostats are not lockable and the controls are accessible by the occupants.

The HVAC equipment and ductwork in general appears to be in poor condition. This is due to the age of the system being 28 years which exceeds its service life. See below for a recent service record summary that outlines failures due to age. Another issue is the indoor equipment is difficult to access for maintenance. The attic has a fair amount of head height, but it is difficult to access through the lay-in ceiling and there is not a platform to walk on in the attic, just bare joists so it's difficult to move around to service equipment and there is fall potential through the joists.

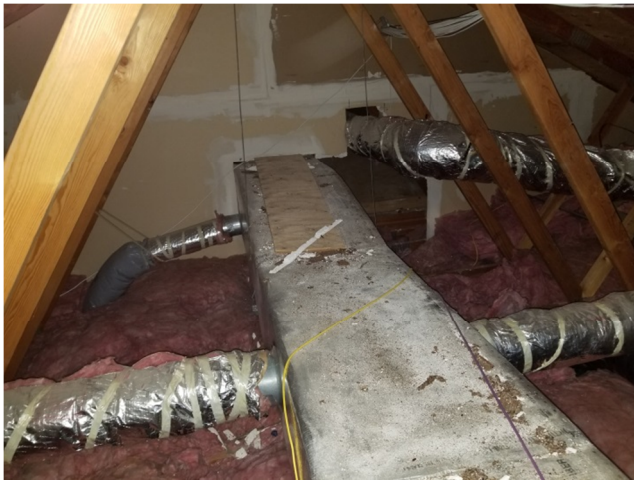
Ductboard Supply Air Main and Branch Ducts

The AH supply air ductwork is distributed via mains in the attics with branches to ceiling supply diffusers in each space. The main ductwork is composed of “ductboard” which is a compressed fiberglass material with a binder. The concern with this duct material is there can be glass fibers in the airstream and potential for mold growth over time. Return air to the AHs is ducted from single return grilles located in open spaces. AH-1 and AH-2 systems are served by return grilles in the central octagonal rotunda. Transfer grilles are provided in some rooms to transfer return air to the open spaces so the air can flow to the respective return grille, some rooms do not have this. This creates issues with return air pathways that can also impact supply airflow because the supply airflow becomes “deadheaded”. Return airflow is especially difficult back to AH-2 because there is a door that prevents return airflow from reaching the rotunda grille when closed. Minimum ventilation air is ducted to the units from small intake grilles in the eaves with fire dampers and taps into the return ducts prior to entering the unit mixing boxes. The systems are not equipped with 100% outside air economizers which are required by current energy code.

Flex duct is used in the industry for landing sheet metal ducts at the supply diffusers and return/transfer grilles. It is not meant to be a primary duct material and should be limited in use. The maximum flex duct length should be 5'-0". There are locations where the use of flex duct is excessive in length and is kinked in many areas which restricts airflow or is slipping off the diffuser/grille connection. Some flex did not appear to be connected at all. This condition is particularly concerning in the West wing where a flex duct was observed disconnected and packed with insulation. The duct insulation wrap observed on round branches are not an industry standard installation, using tape spiraled around and is coming apart in areas. Many ducts appear to be resting on the attic blanket insulation in many areas, all ducts need independent support and secured to building structure. The ducts need to be sealed tight to minimize leakage, observed the seals to be coming apart in areas.

- Replace all ductboard with galvanized sheet metal ductwork, properly seal, and support from structure. Repair the duct routing in the West wing and limit flex duct.

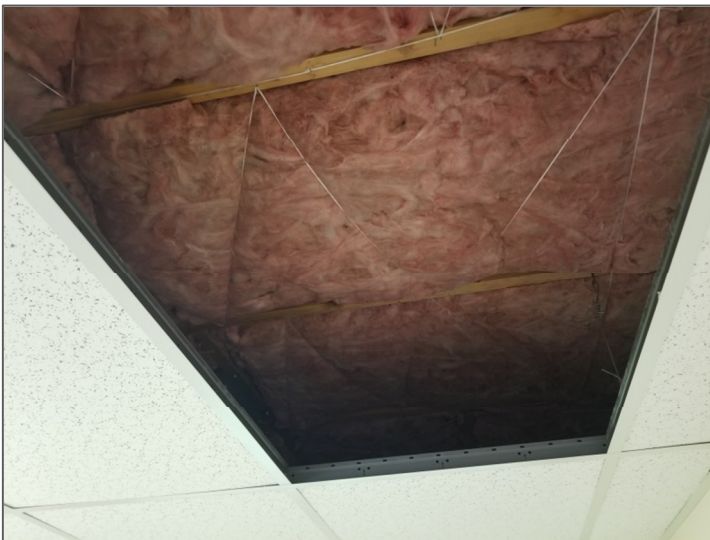
Unfaced Batt Insulation Above Lay-in Ceiling

The existing thermal barrier consists of unfaced R-30 batt insulation located between the 24" on center ceiling joists and held in place by twine attached to the bottom of the joists. In many areas the insulation has been disturbed or is missing entirely. There is no gypsum or plywood sheathing on either the top or bottom of the joists. There is a lay-in ceiling approximately 12" below the joists (dimension should be field verified throughout) that forms a plenum of sorts. There seems to be fiberglass dust suspended in the air both in the attic and plenum. When ceiling tiles are removed some of this dust drops into the occupied space. The lay-in ceiling is not air-tight because the removable tiles rest on a grid and air gaps can occur where the tiles are warped or not set properly. Air also passes through gaps in light fixtures, ceiling diffusers, and other devices in the ceiling. Therefore the lay-in ceiling cannot be considered a pressure barrier.

- There is no pressure barrier provided for the attic. Since the attic is vented the roof is not a pressure barrier either. Because of this the air exchanges freely between the unconditioned attic and the conditioned space, this is called infiltration. This results in heat, moisture, and particle transfer between the attic and occupied spaces that counteracts the performance of insulation and HVAC systems.

- Areas where the insulation is disturbed or missing short circuits the thermal barrier and allows unwanted heat loss and heat gain.
- The indoor HVAC equipment is located in the unconditioned attic which is allowed, but not considered ideal. The large seasonal temperature fluctuations in the attic require additional insulation wrap for the ducts and AH units (per the energy code) and exposure to these temperatures can shorten the equipment life. Also, if the ducts are not sealed properly the infiltration issues outlined above will be increased. Based on observations the ducts do not appear to be adequately sealed.
