Orcas Island Health Clinic

Heating, Ventilating, and Air Conditioning System Review and Recommendations Report

7 Deye Lane
Eastsound, WA 98245

18 June, 2019

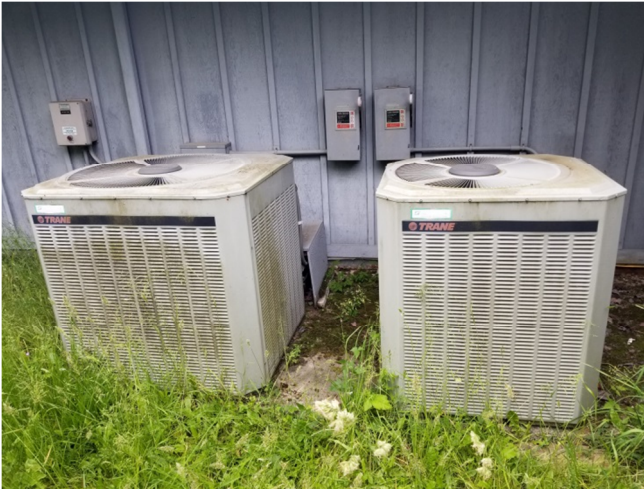
Outdoor Heat Pumps (HPs)

The HVAC equipment and ductwork in general appears to be in poor condition. This is due to the age of the system being 28 years which exceeds its service life. See below for a recent service record summary that outlines failures due to age. Another issue is the indoor equipment is difficult to access for maintenance. The attic has a fair amount of head height, but it is difficult to access through the lay-in ceiling and there is not a platform to walk on in the attic, just bare joists so it's difficult to move around to service equipment and there is fall potential through the joists.

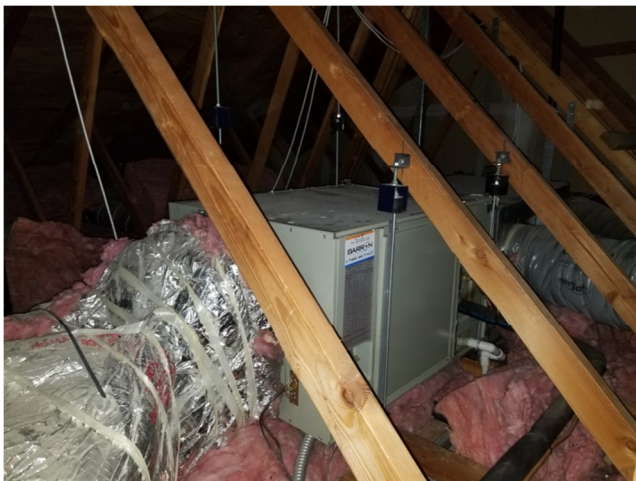
Air Handler in Attic (AHs)

- Areas where the insulation is disturbed or missing short circuits the thermal barrier and allows unwanted heat loss and heat gain.
- The indoor HVAC equipment is located in the unconditioned attic which is allowed, but not considered ideal. The large seasonal temperature fluctuations in the attic require additional insulation wrap for the ducts and AH units (per the energy code) and exposure to these temperatures can shorten the equipment life. Also, if the ducts are not sealed properly the infiltration issues outlined above will be increased. Based on observations the ducts do not appear to be adequately sealed.

- Recommend providing plywood walking platforms in the attic secured to the open joists. Platforms to extend from the attic access points to the HVAC equipment for fall prevention safety and ease of maintenance.
