Inspection Report

7 Deye Lane, Eastsound, WA 98245

Inspection Date: 7/7/2018
Report ID: 20180707-7-Deye-Lane

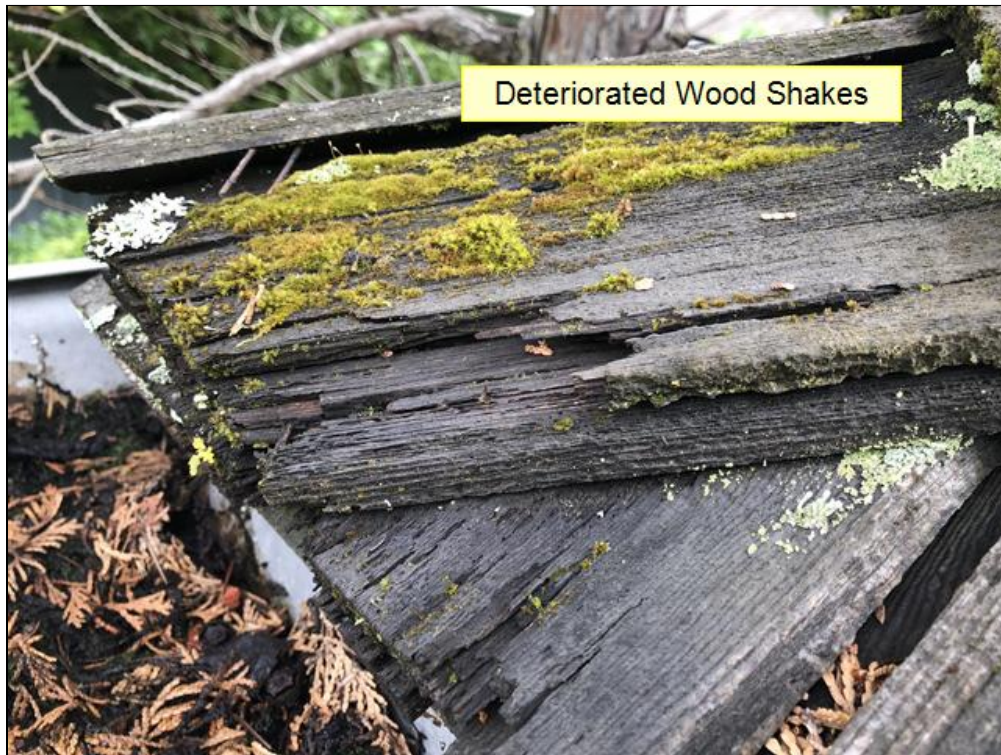
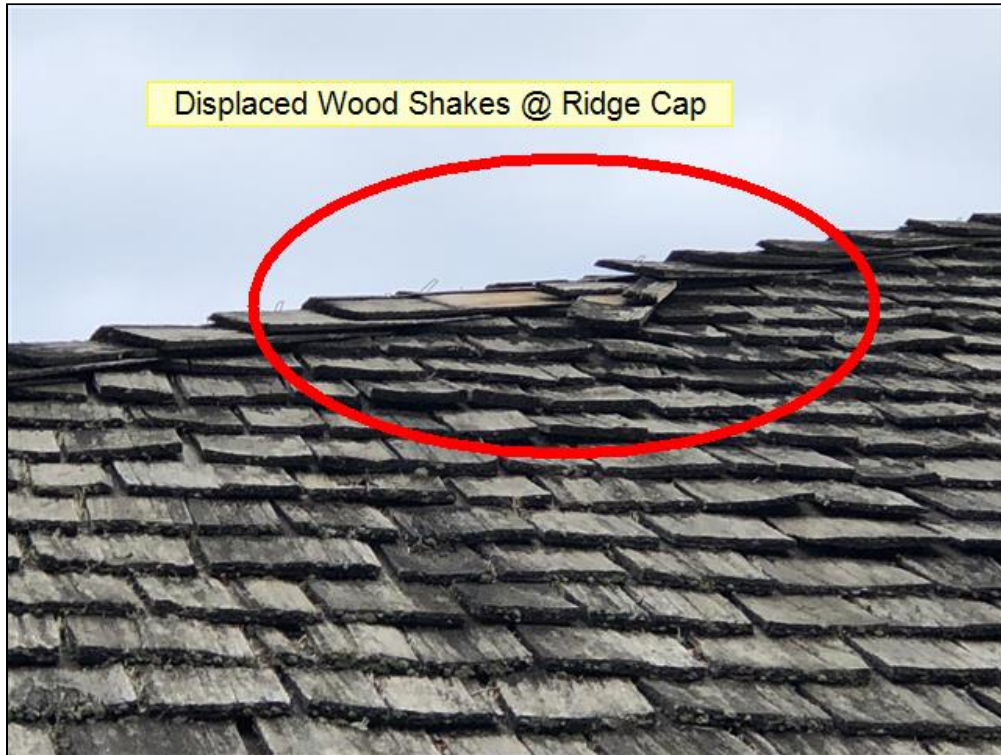
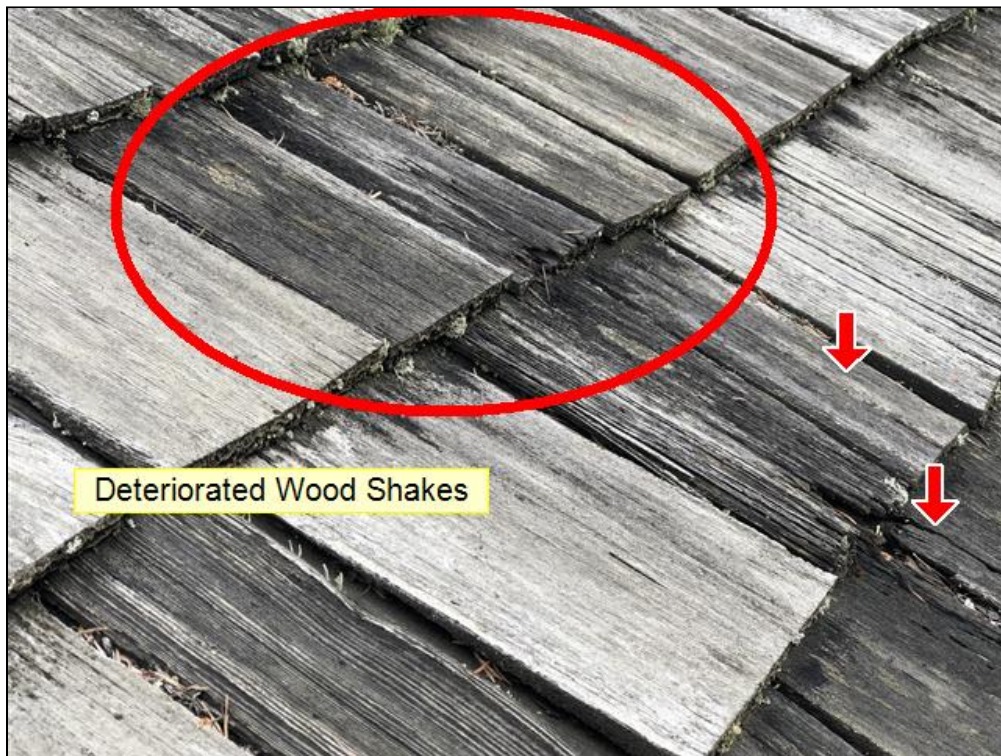
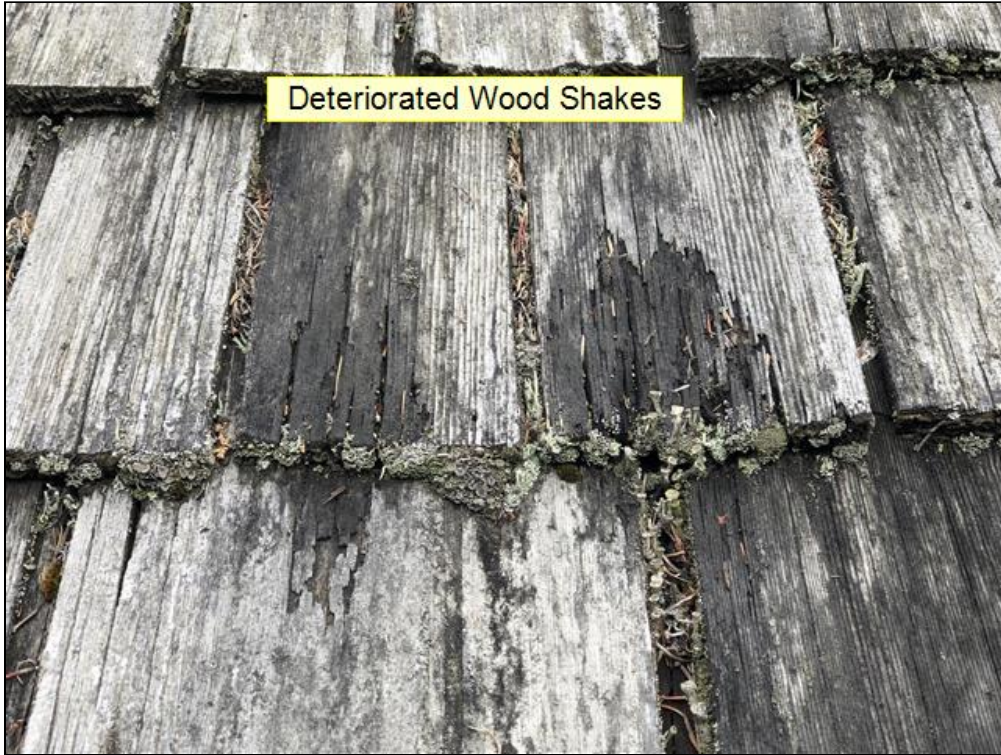
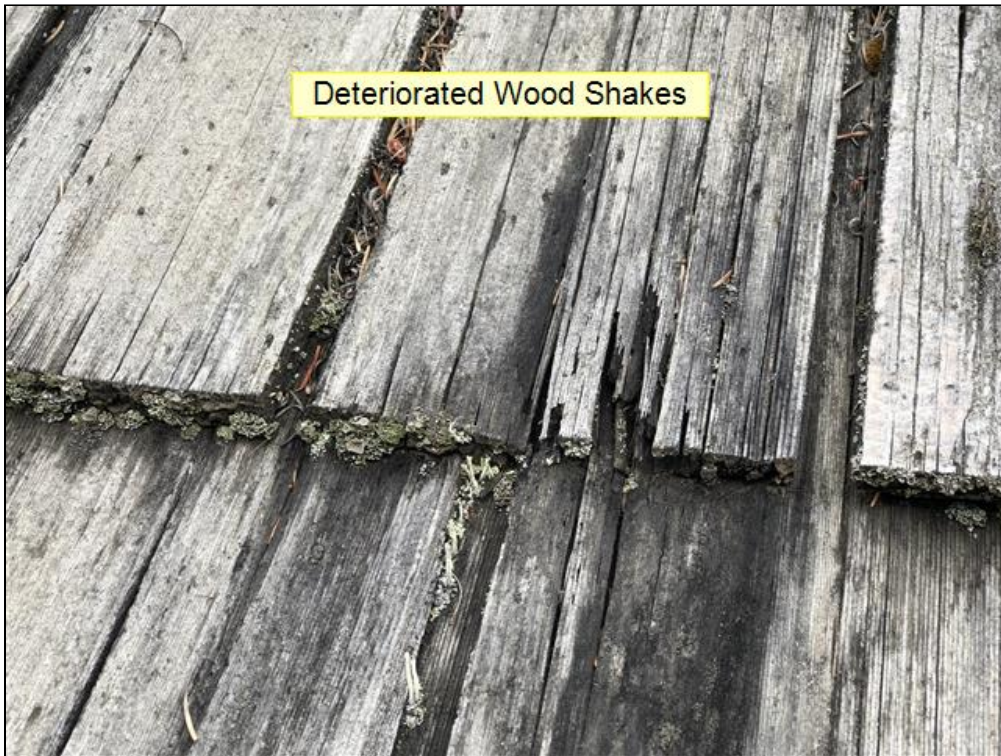
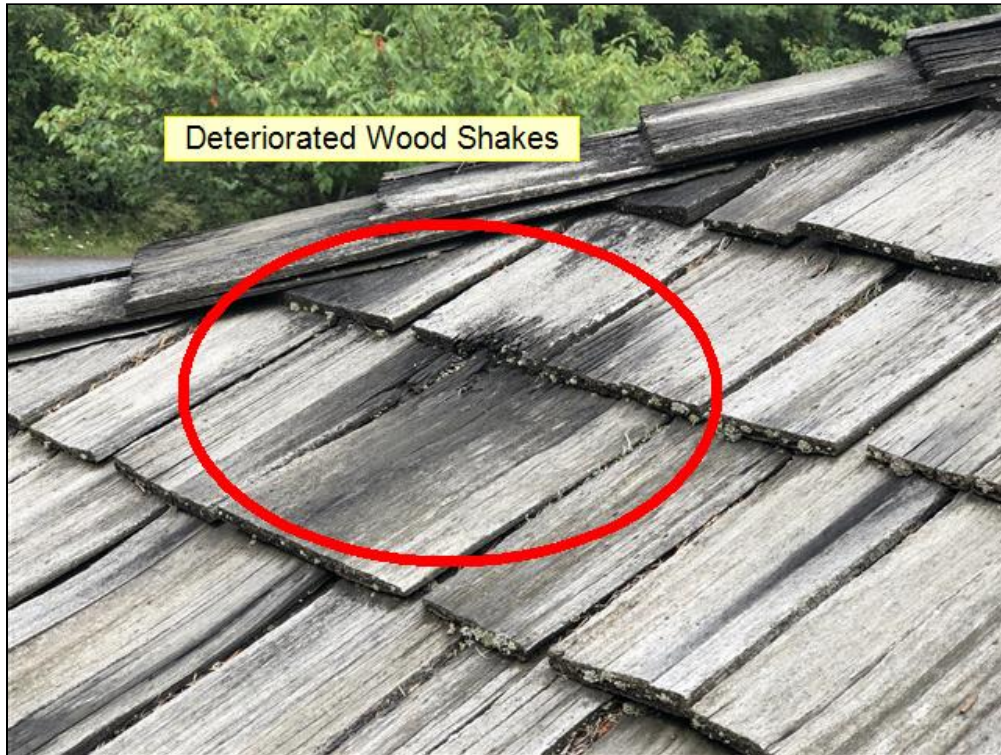
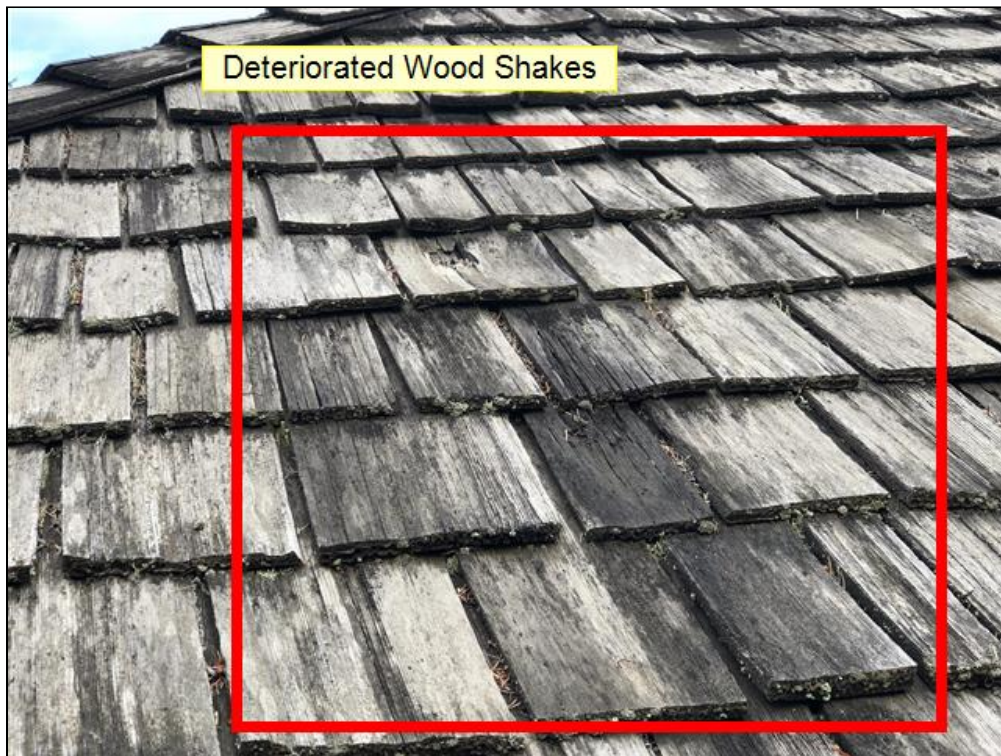
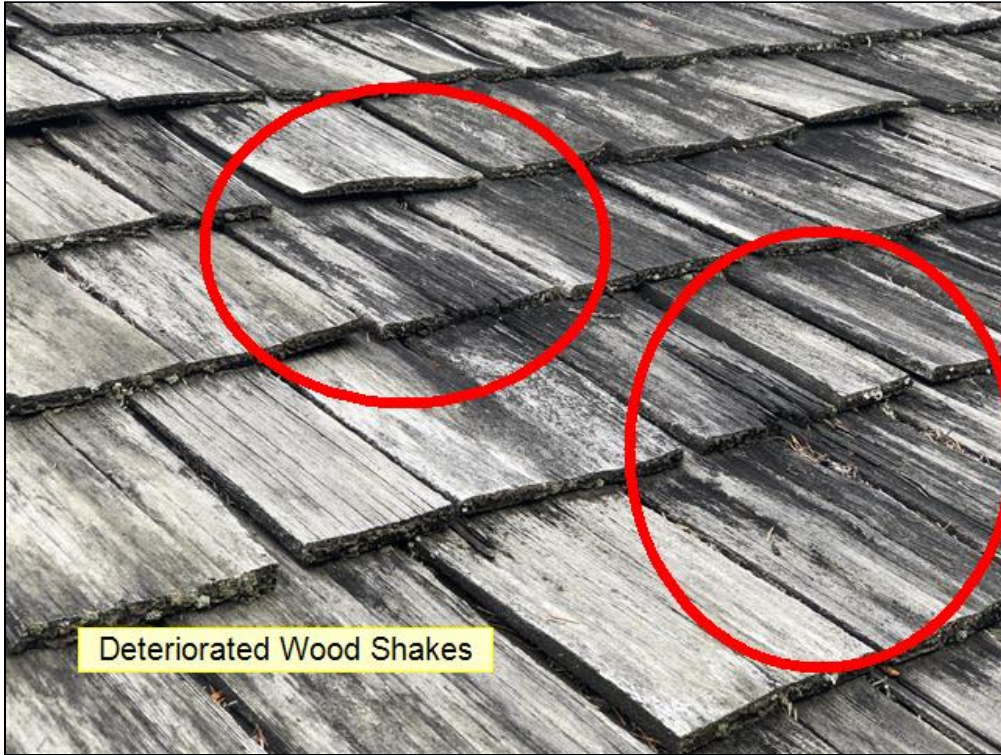
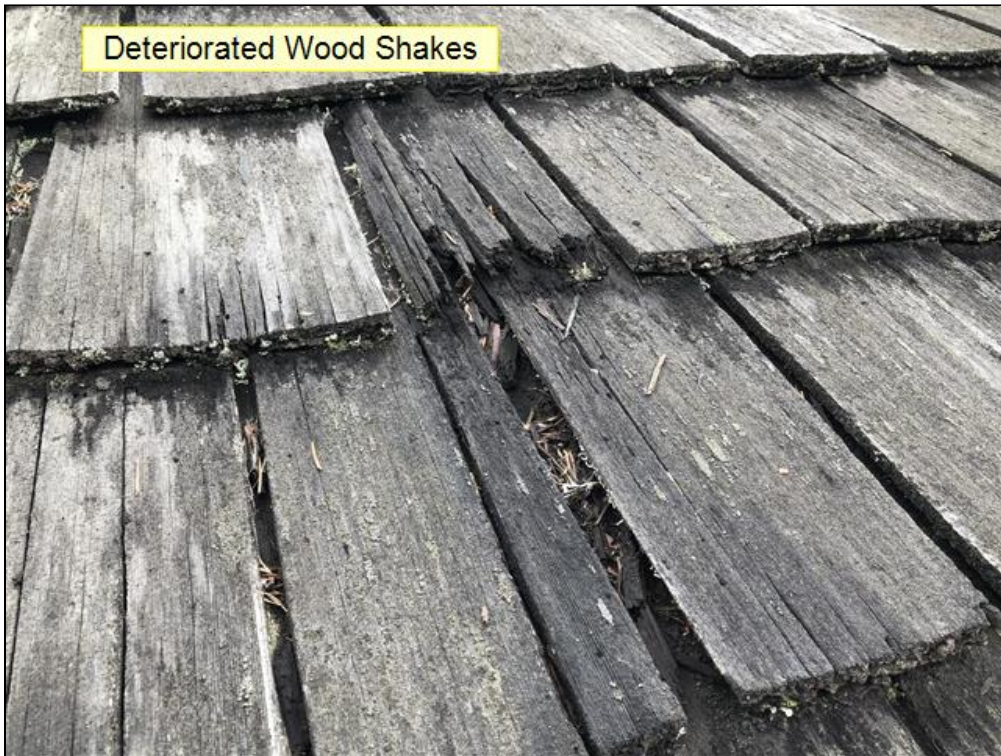
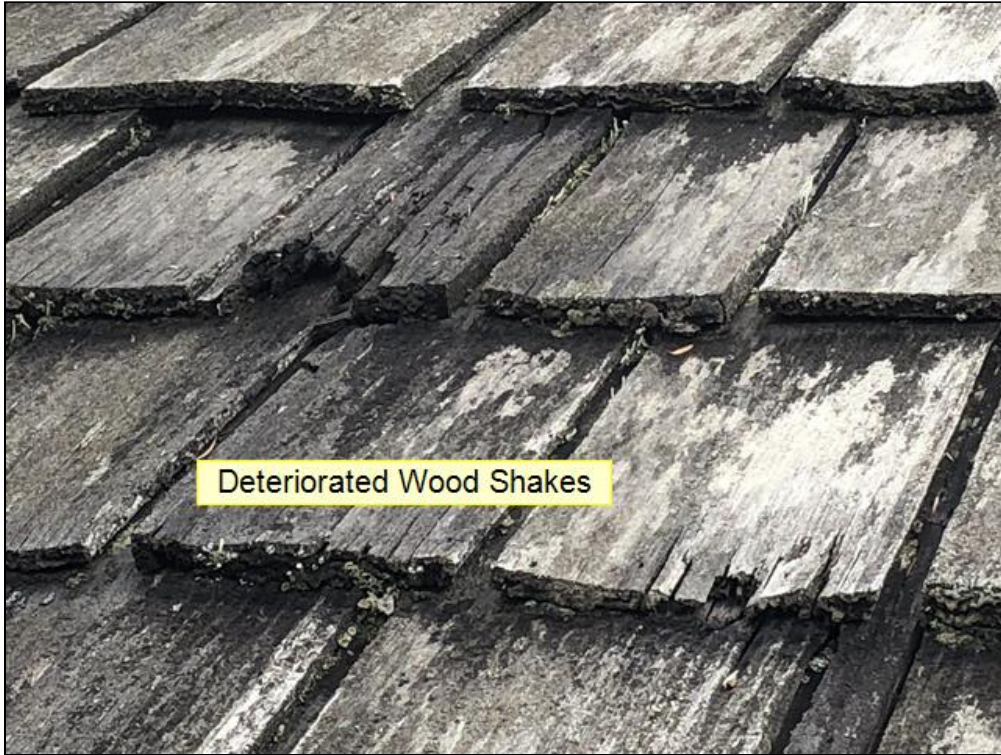
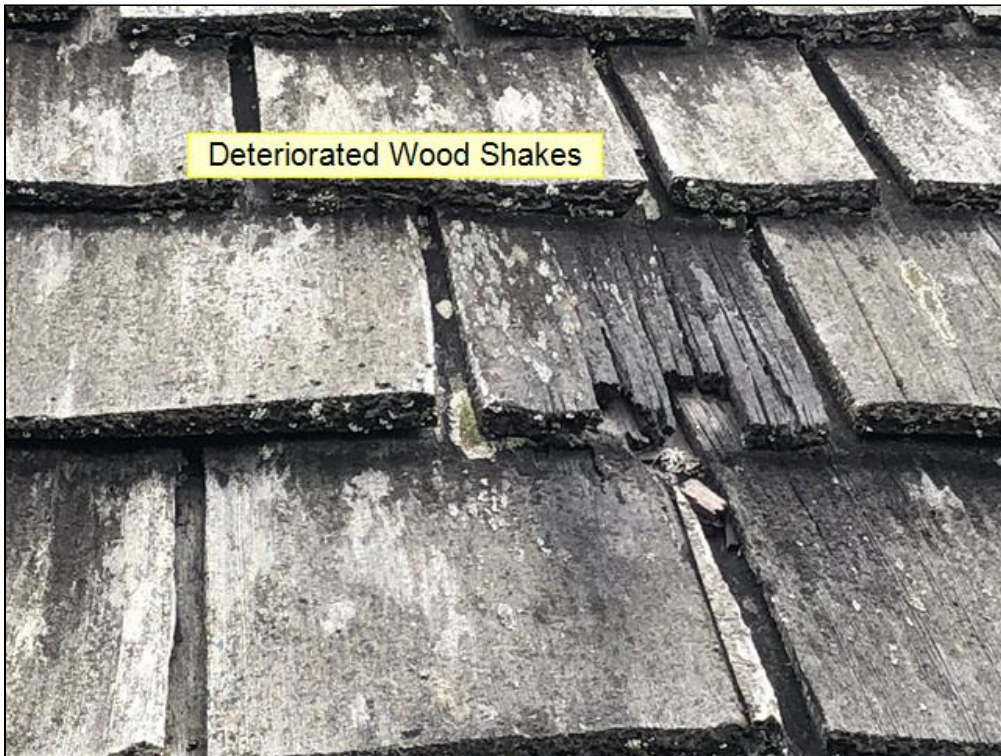
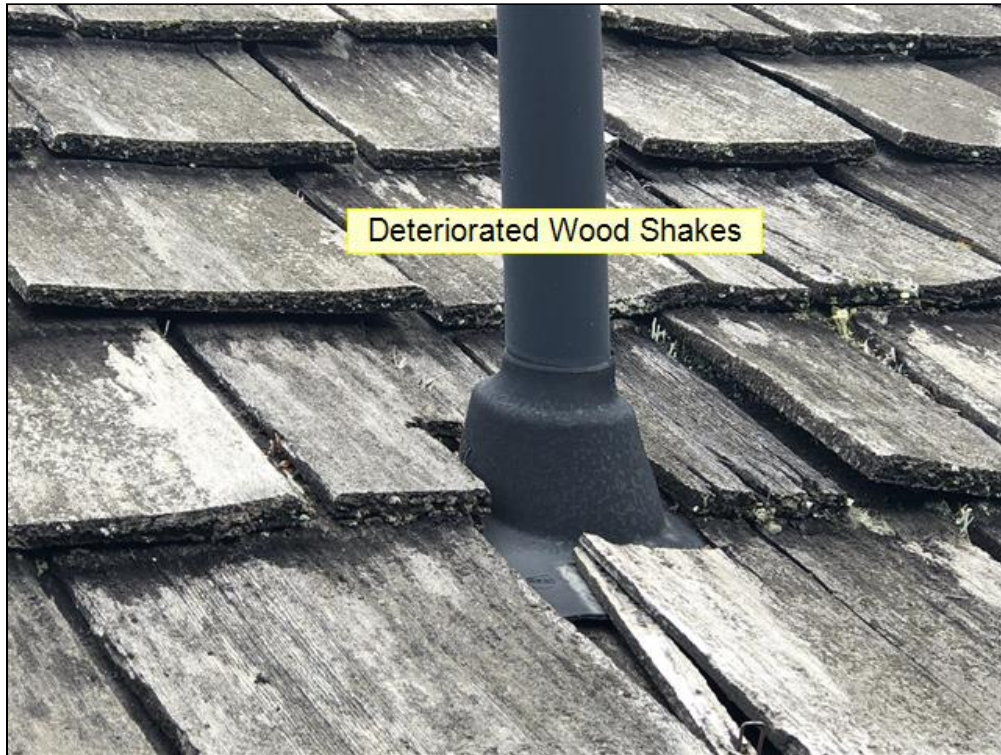
(1) **Major Issue:** The wood shake roof coverings are in marginal-to-poor condition, indicating that replacement will likely be necessary within the next 1-5 years. A significant amount of deteriorated wood shakes were noted, some of which are displaced, requiring repair as soon as practical. Numerous prior repairs have been undertaken over time, some of which appear recent. Generally, as a rule of thumb, when 20-25% of the roof coverings require repair, replacement is undertaken. The roof coverings are definitely close to requiring replacement; most roofing contractors would likely advise replacement as soon as practical. I was not able to safely or reasonably traverse the roof at the time of inspection as it rained last night and the roof coverings were very slippery; accordingly, I viewed the roof from a ladder at the eaves. See attached representative pictures documenting the roof at the time of inspection.

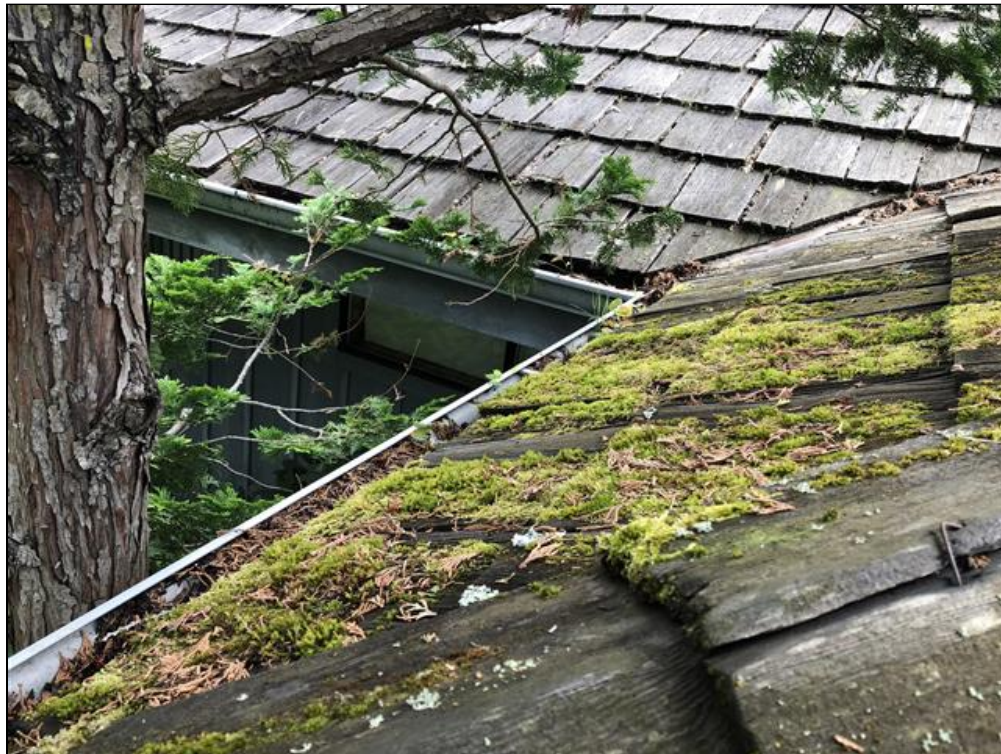
1.0 Item 13(Picture)

(2) **Repair:** The roof coverings are starting to show signs of organic growth. Treating, not pressure washing, is recommended to extend the useful life of the roof coverings and to prevent moisture intrusion. Visual inspection of the roof coverings under moss growth are necessarily limited. See attached picture.

(3) **FYI:** Treatment of the roof coverings on a semi-annual basis as a preventative measure against moss growth is advised.

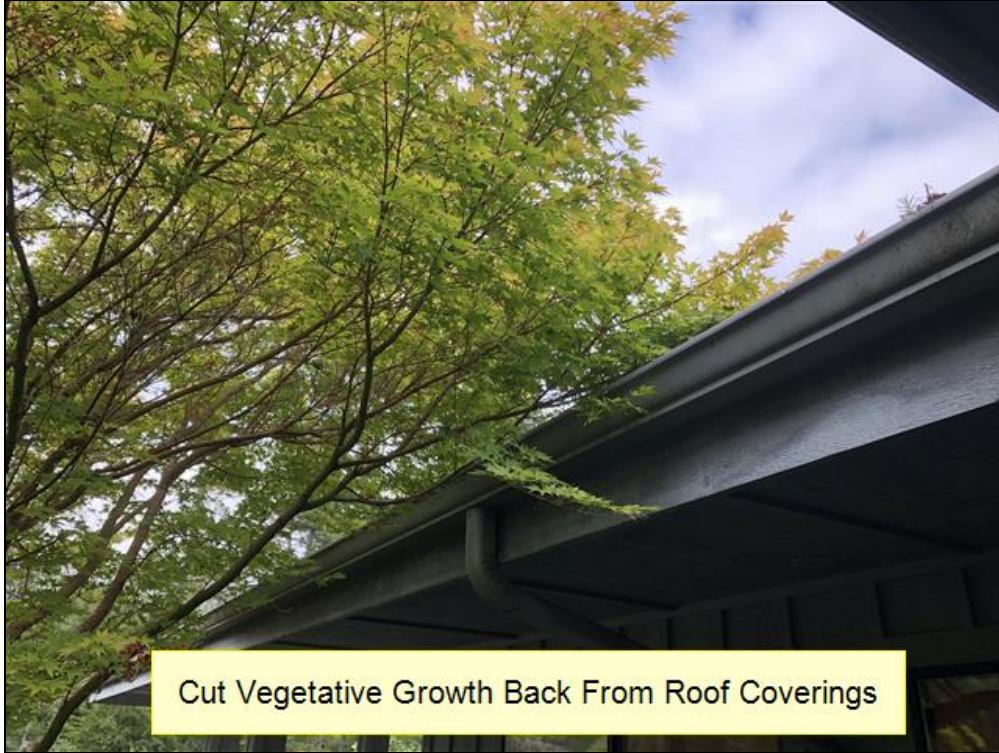
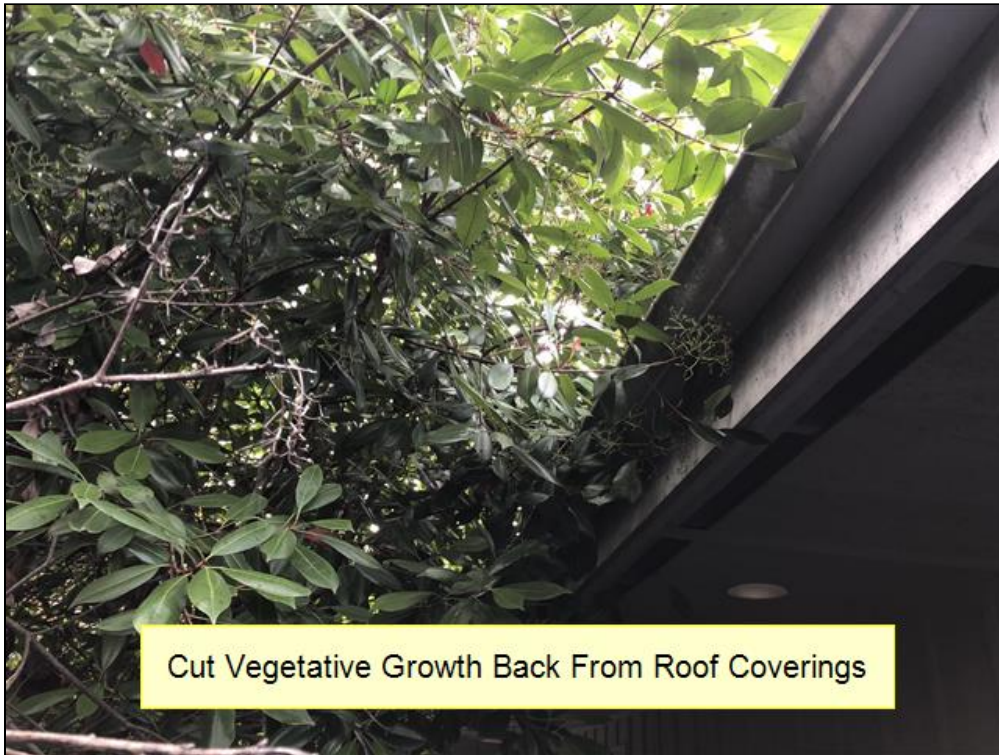
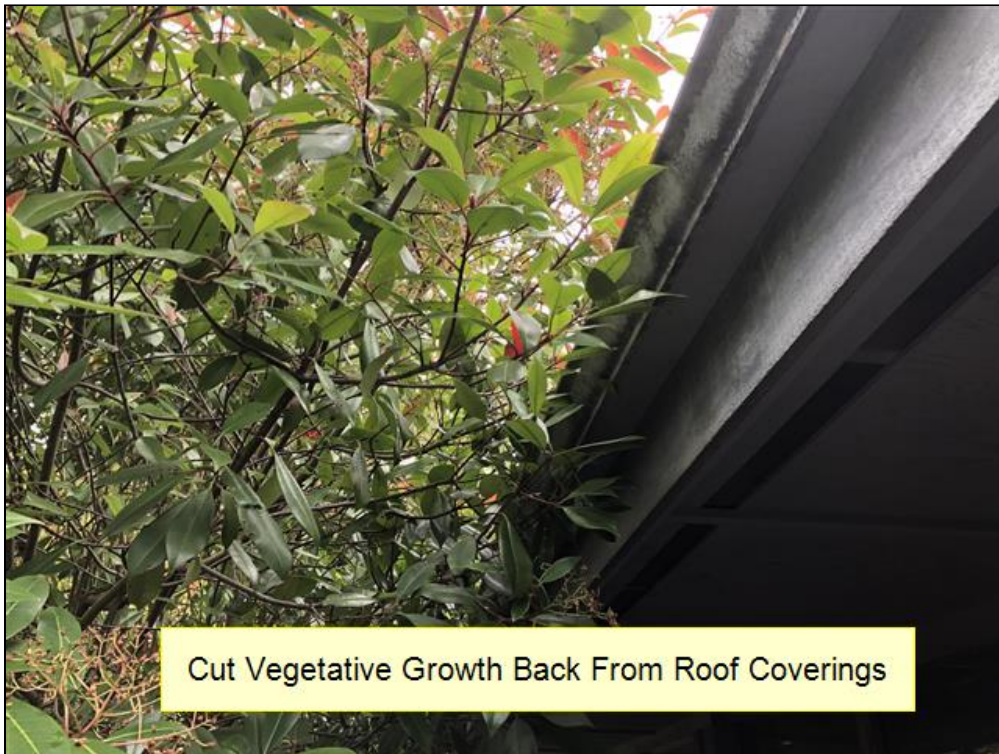
(4) **Repair:** Tree limbs and/or vegetative growth that are in contact with roof or hanging near the roof should be trimmed to prevent mechanical damage and to extend the useful life of the roof coverings. This was noted on all sides of the building. See attached pictures.

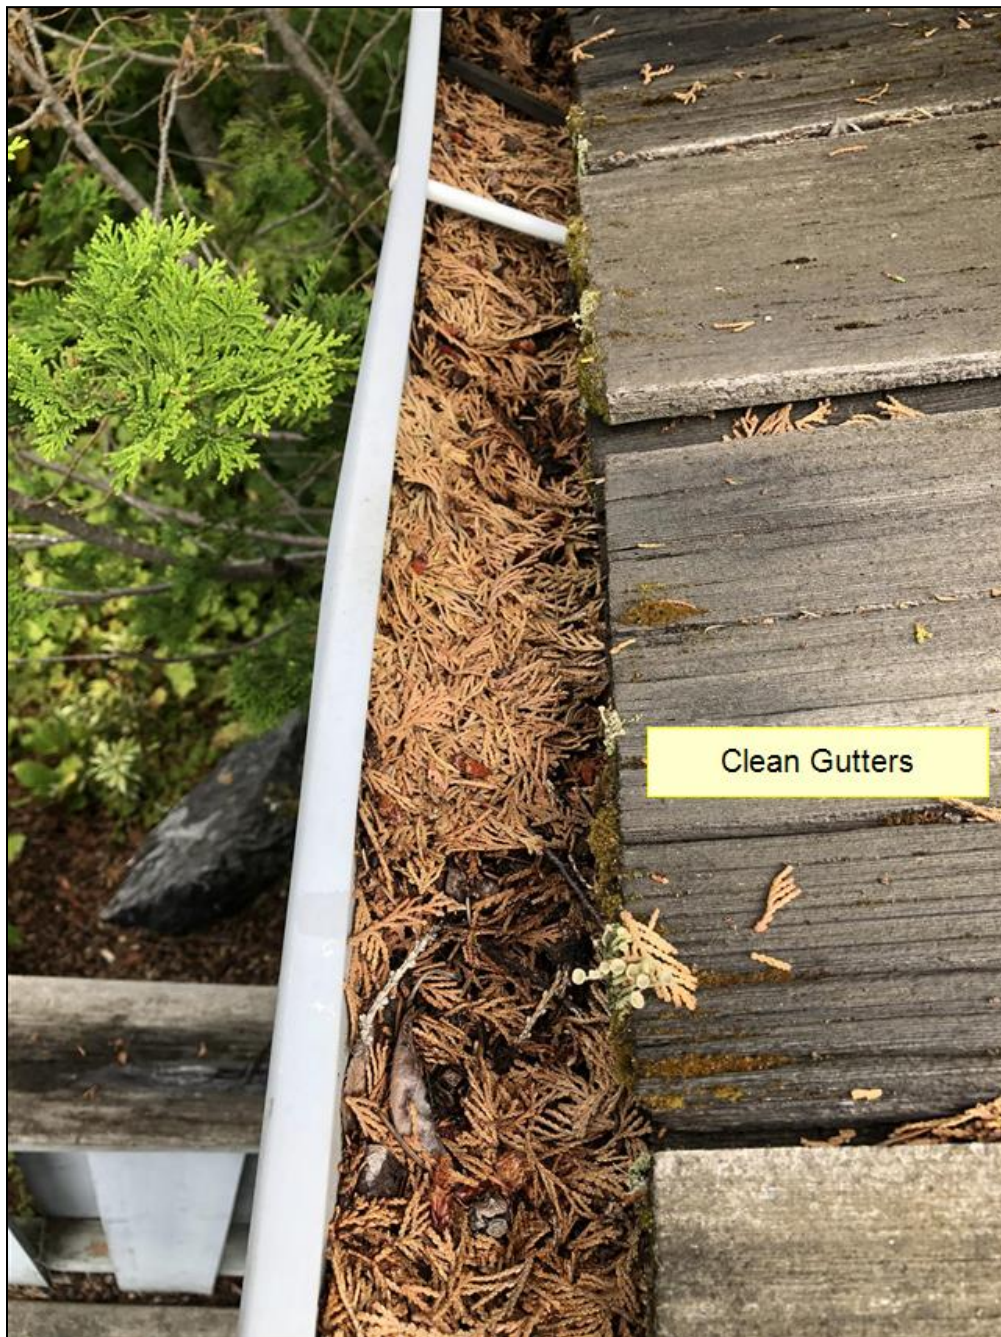
1.3 Item 1(Picture)

Repair: The gutters are full of debris in areas and need to be cleaned. Keeping your gutters clean will ensure proper function and protect the exterior envelope of the building from water intrusion. See attached picture.

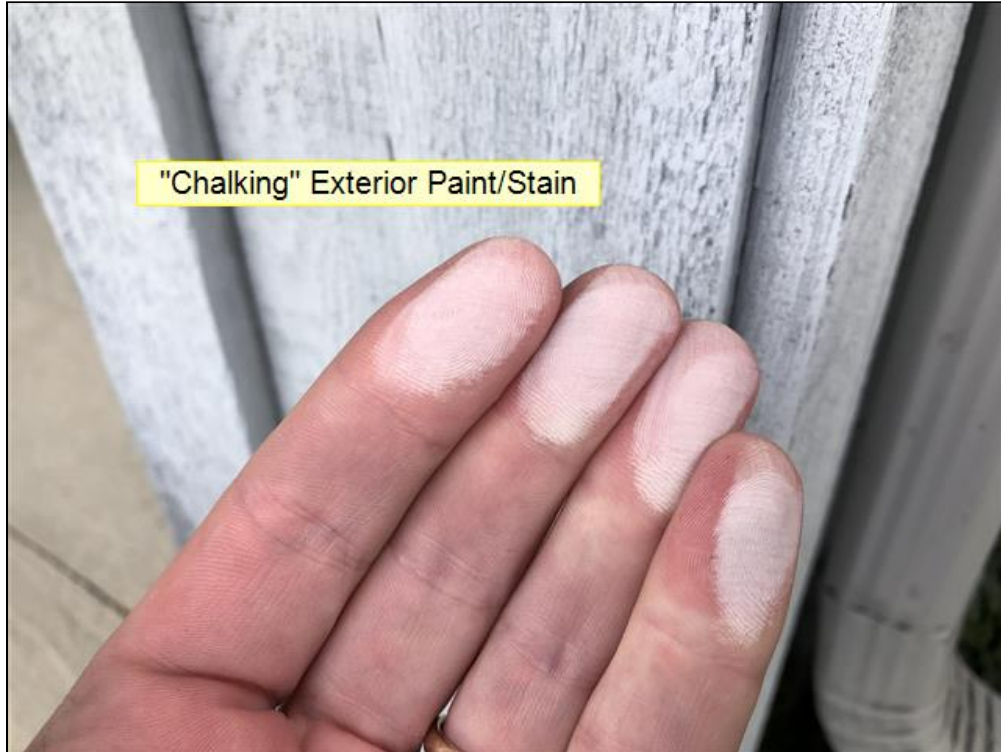
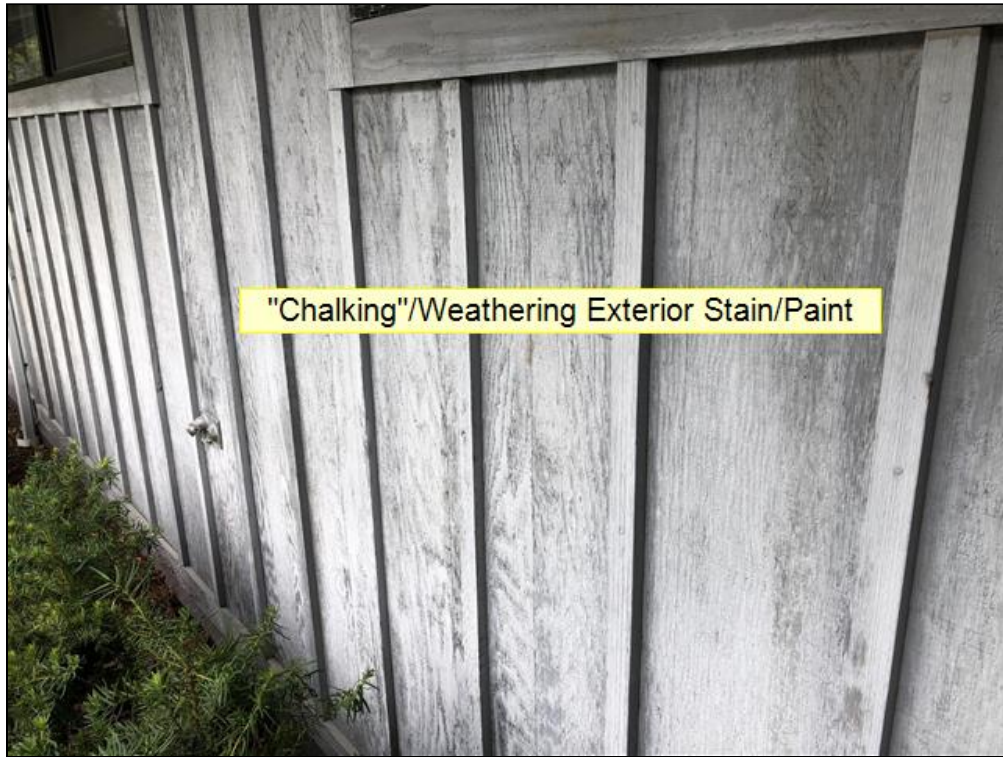
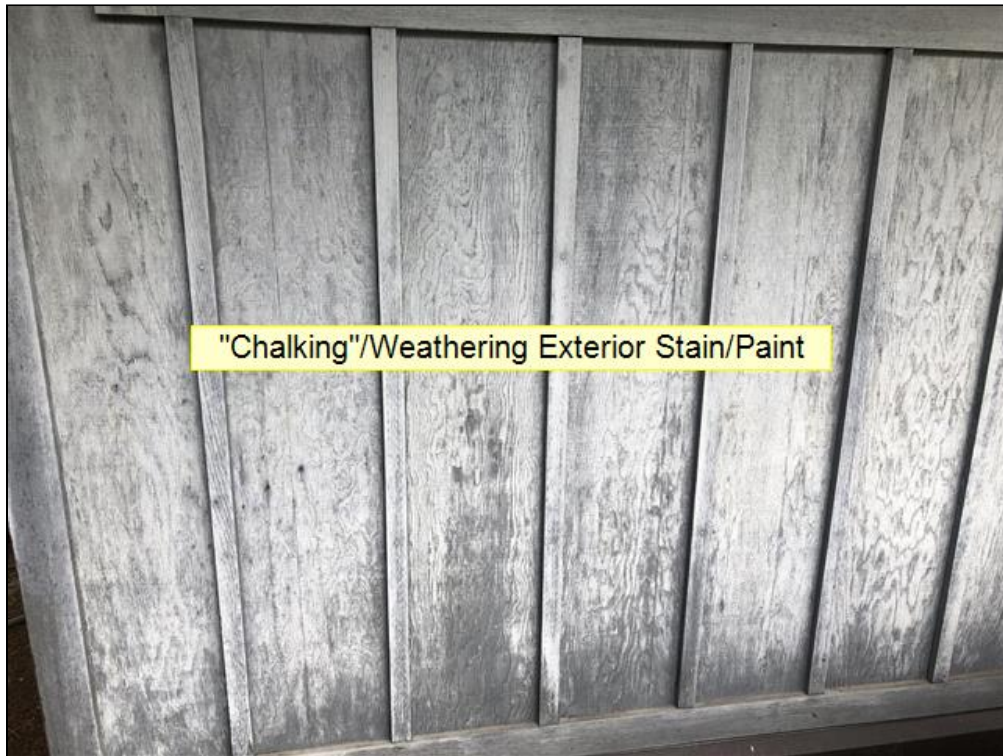
(2) **Repair:** The exterior paint/stain is approaching the end of its serviceable life, as evidenced by characteristic "chalking"/weathering presenting on some of the exterior surfaces. See attached pictures. Budgeting for new paint/stain in the near future is advised.

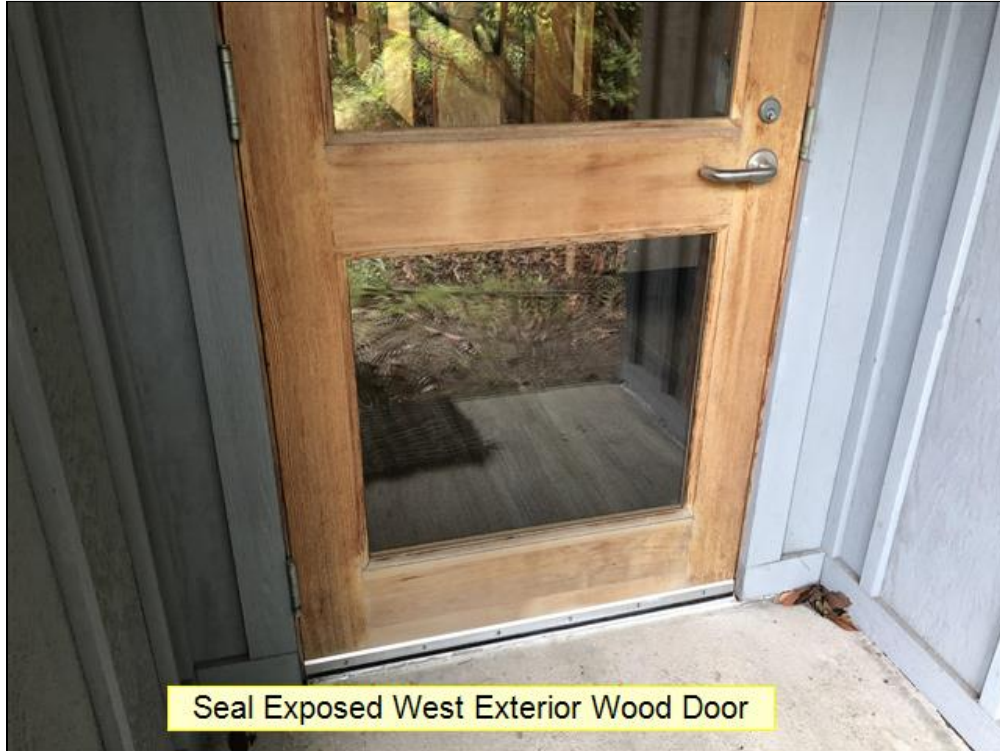
2.1 Item 1(Picture)

Repair: Staining or otherwise sealing exposed wood at the two (2) western exterior doors is advised to prevent water damage and extend serviceable life. Additionally, the side west exterior door rubs against its self-closing hinge, putting the hinge and door at risk of mechanical damage. See attached pictures.

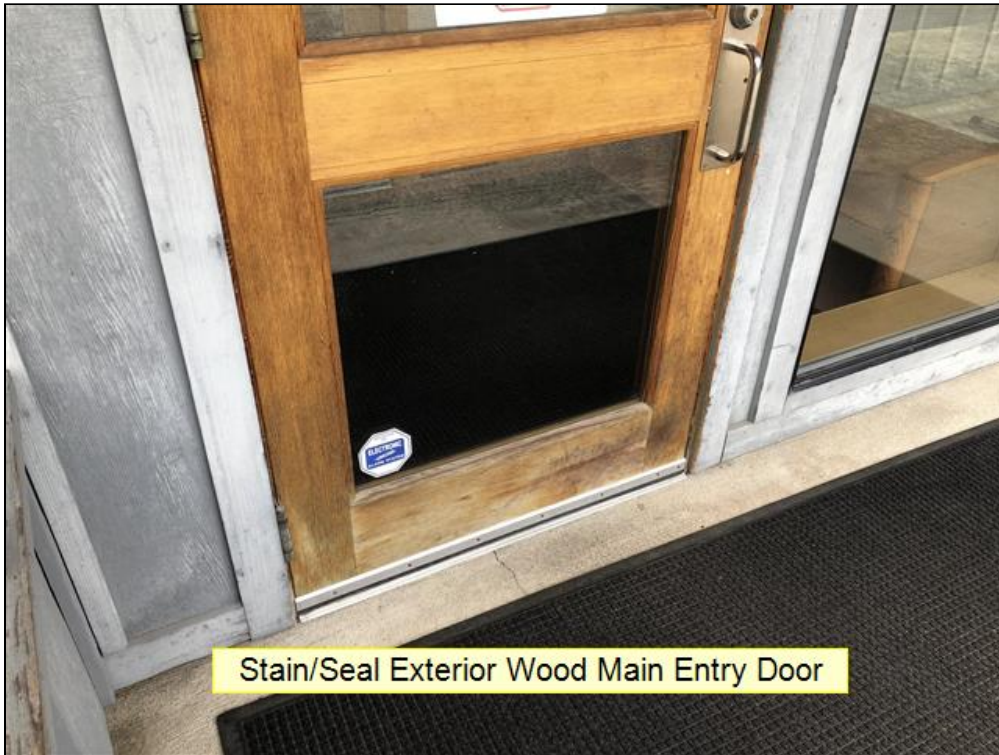
2.1 Item 2(Picture)

Stain/Seal Exterior Wood Main Entry Door

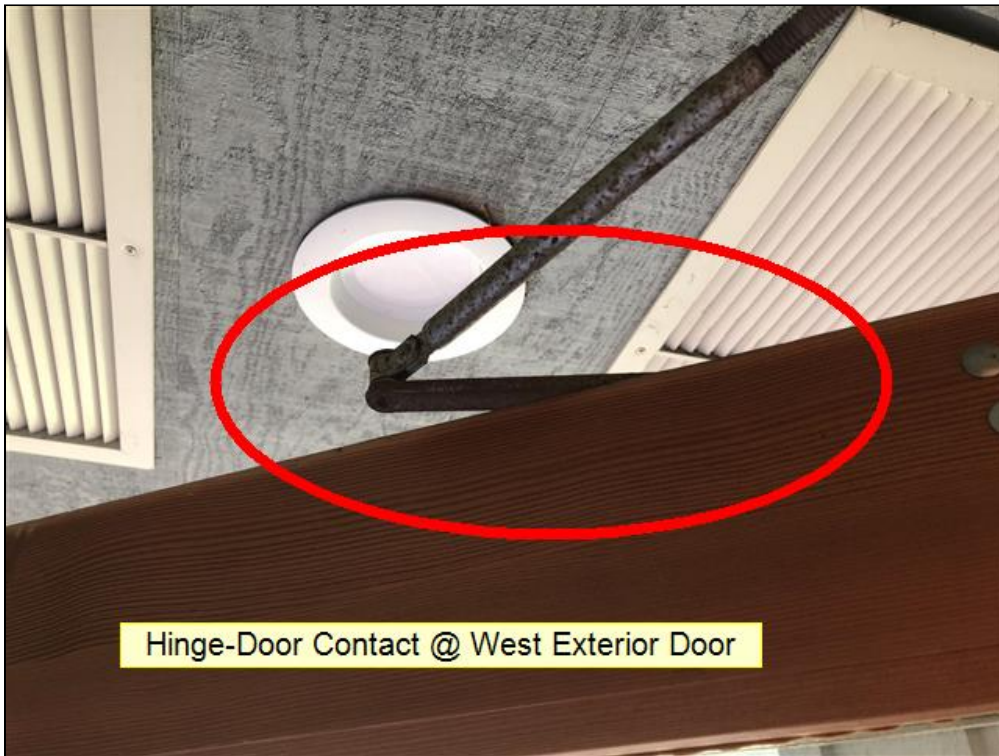
2.1 Item 3(Picture)

Hinge-Door Contact @ West Exterior Door

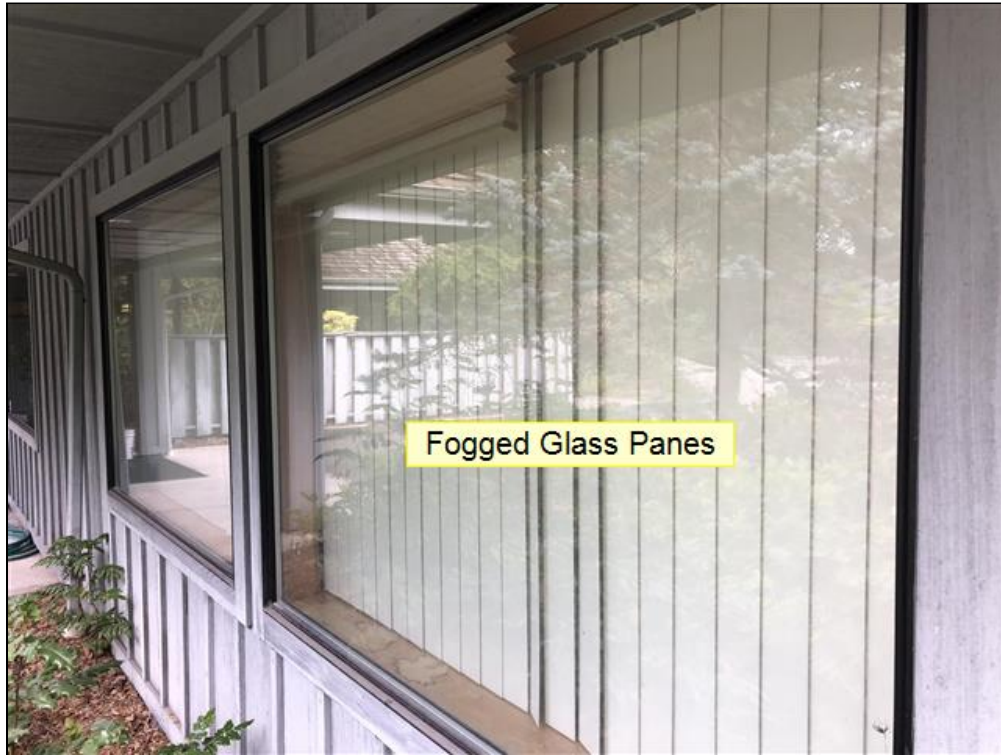
2.2 Item 1(Picture)

(1) **Improve:** Some of the window panes in this building appear to have lost their seals and exhibit the characteristic "fogged" appearance; fogged window panes are generally considered a cosmetic issue in the

home inspection industry. This was noted at a SE picture window; many of the windows were dirty at the time of inspection which made making definitive determinations difficult (this was the only window noted that is clearly "fogged"). See attached picture.

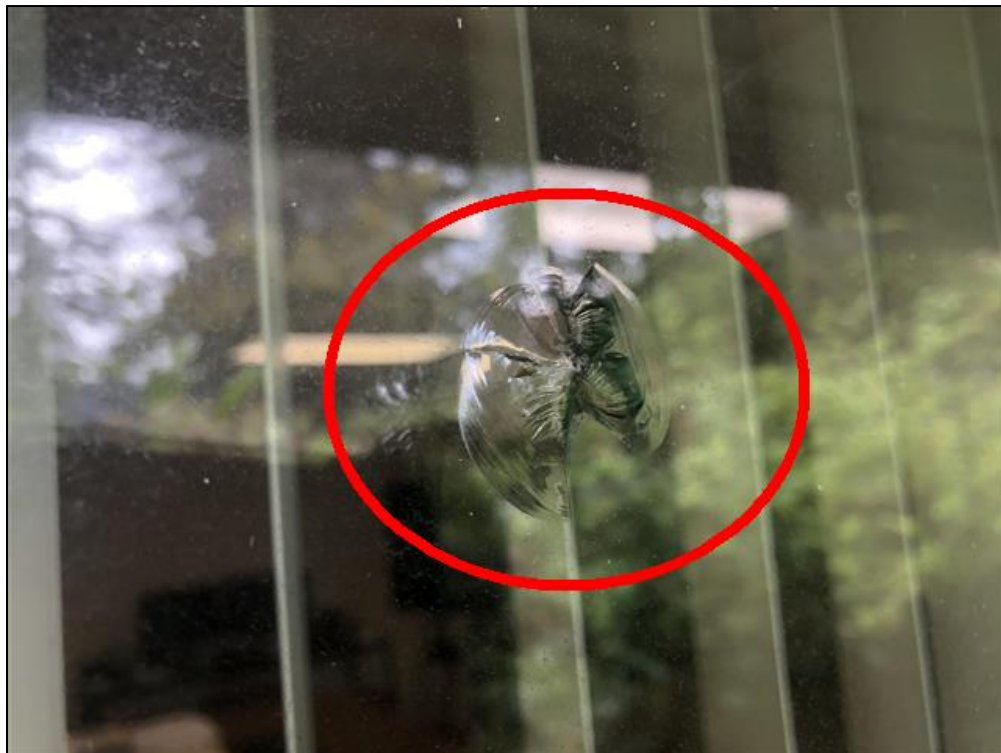
2.2 Item 2(Picture)

(2) **Repair:** An eastern picture window is rock-chipped. See attached picture.

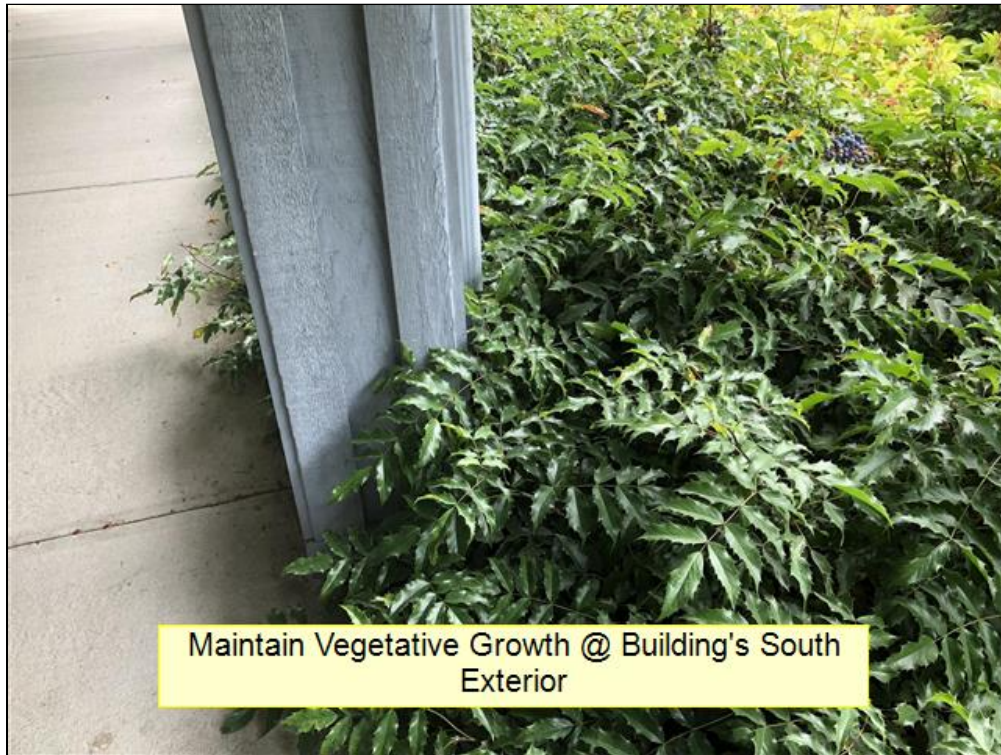
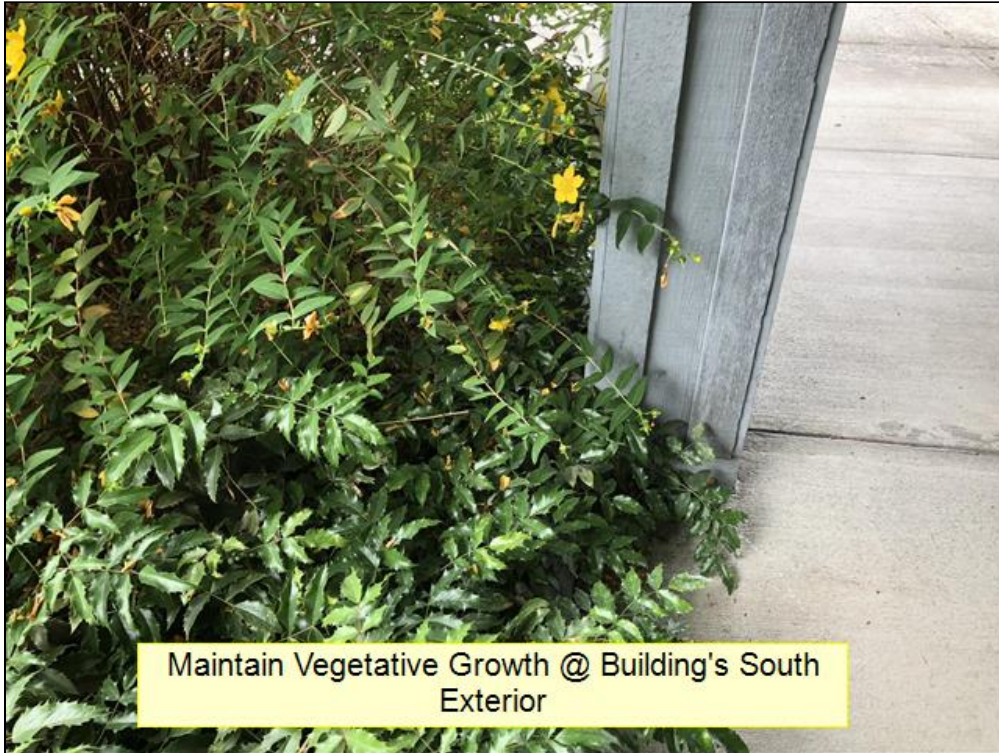
Repair: Landscaping elements and vegetative growth should be trimmed away from the building exterior to prevent moisture and insect damage. This was noted in particular at the southern exterior. Eighteen inches clearance is recommended; when not practical, avoid direct contact between vegetative growth and the building envelope. Visual inspection of the exterior elements is restricted by landscaping elements that are in direct contact with and obscuring the building's exterior from visual inspection.
