Inspection Report

7 Deye Lane, Eastsound, WA 98245

Inspection Date: 7/7/2018
Report ID: 20180707-7-Deye-Lane

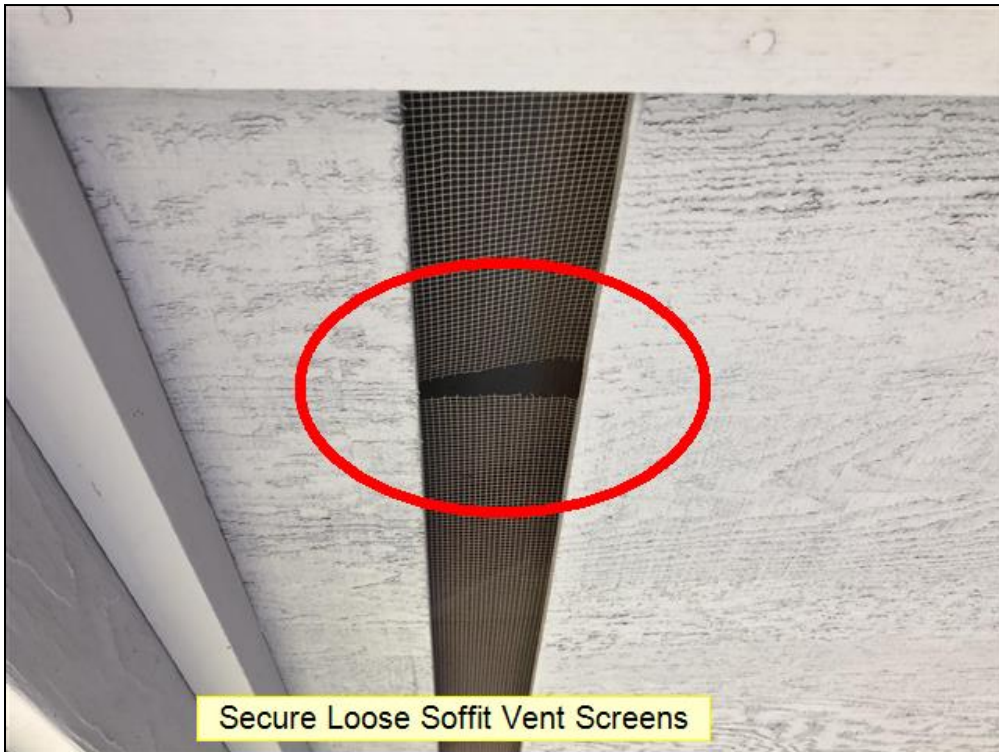
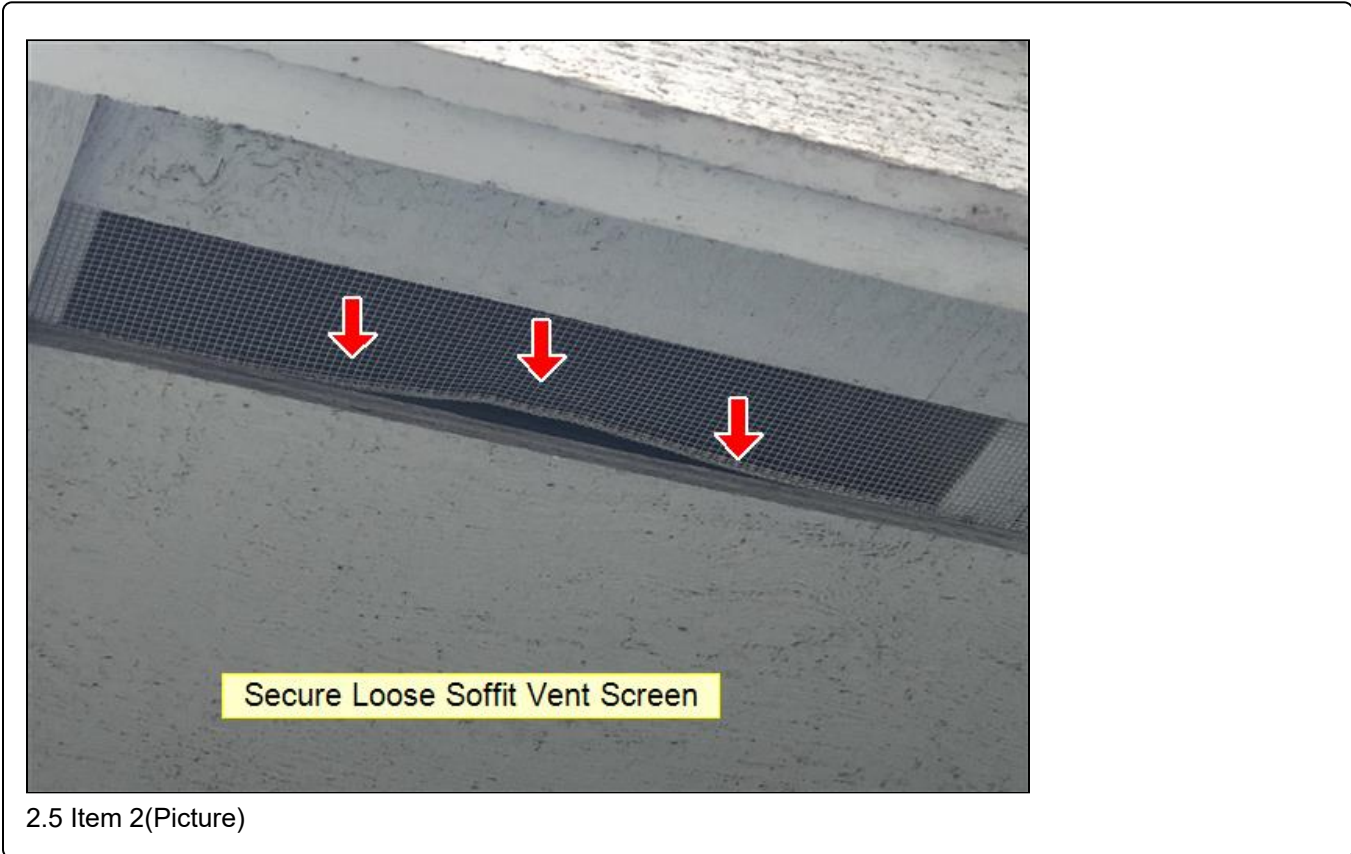
Repair: A few (minor) loose soffit vent screens were noted at the southern and northern eaves. See attached pictures. Securing loose vent screens is advised to help prevent bird/vermin intrusion into the attic areas.

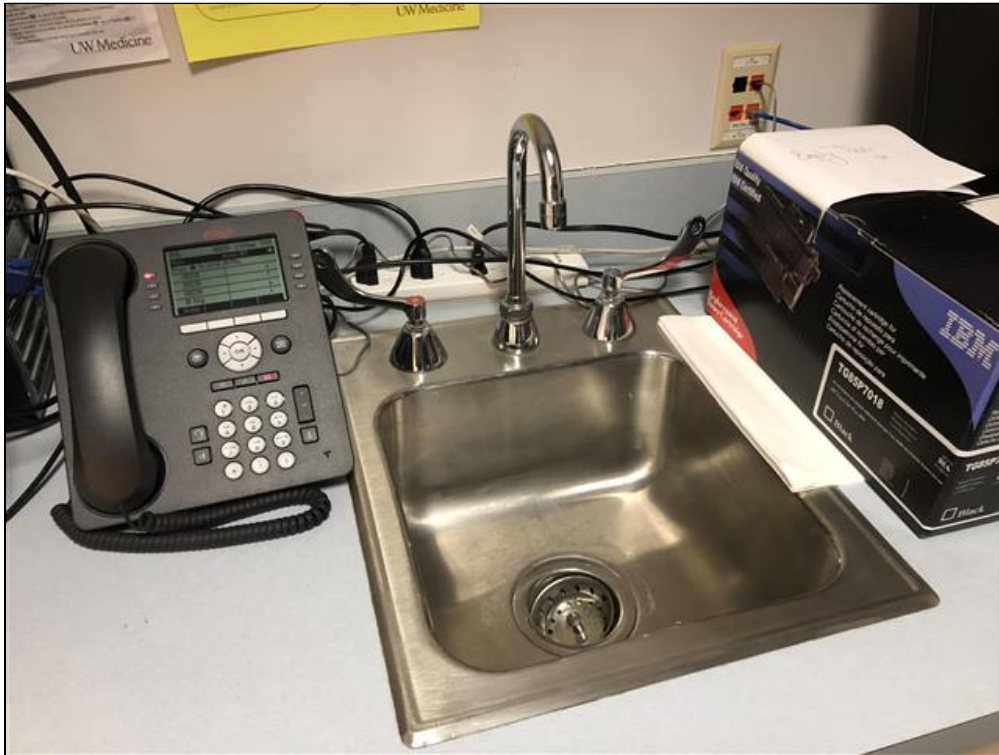
5.1 Item 1(Picture)

(3) **Repair:** Water was intentionally turned off at the sink supply valves to the XRAY laboratory sink for reasons unknown.

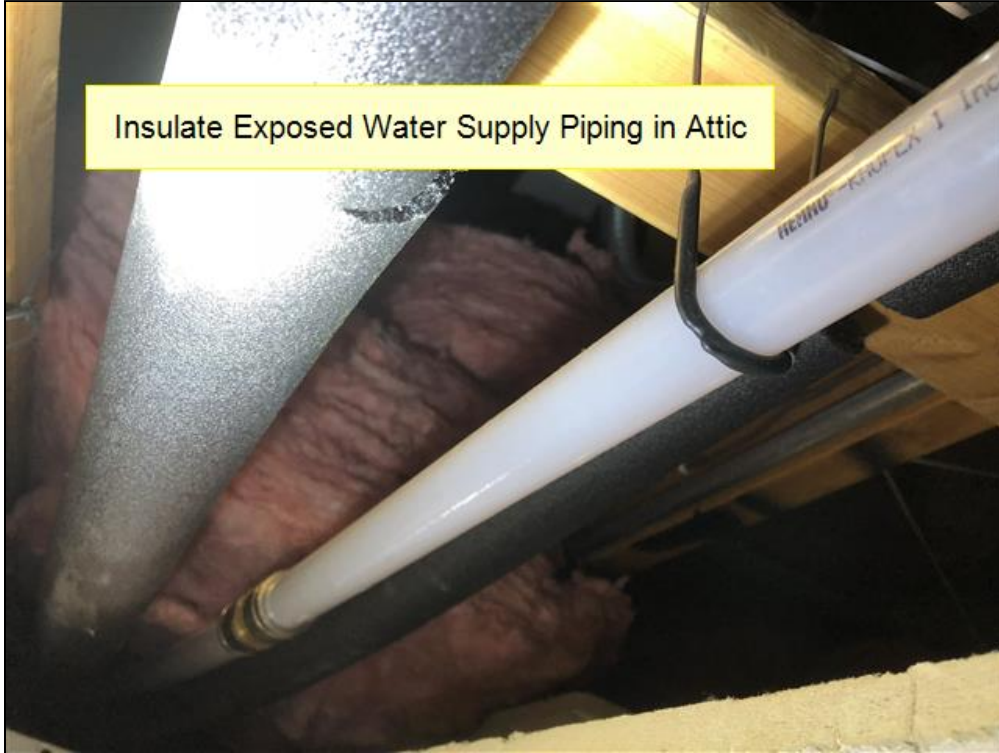
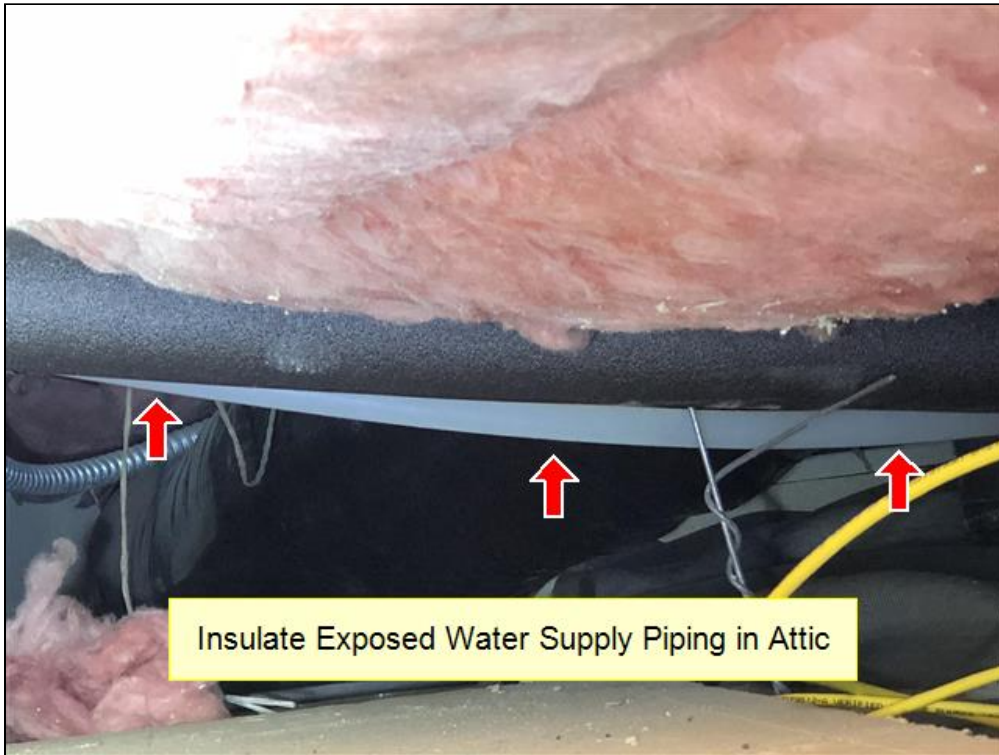
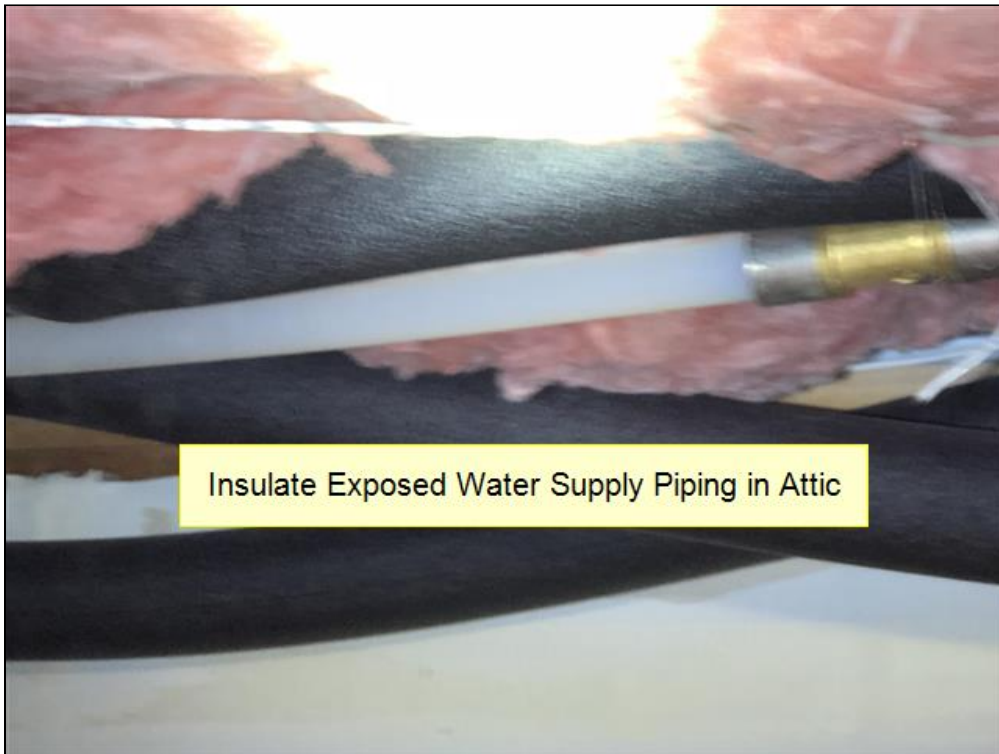
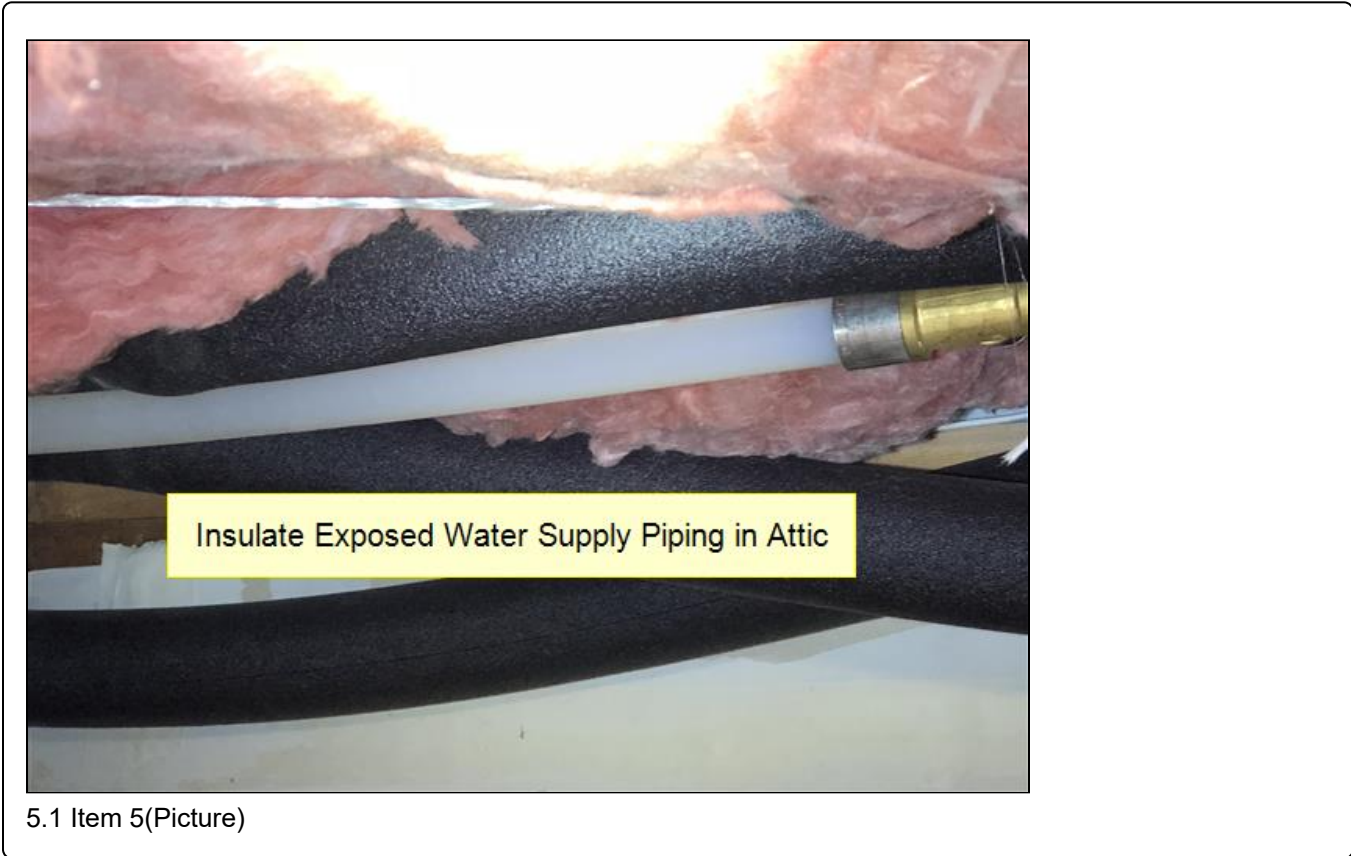
(4) **Repair:** I recommend you insulate exposed water supply pipes in the attic areas to help prevent breakage during freezing weather conditions. See attached representative pictures.

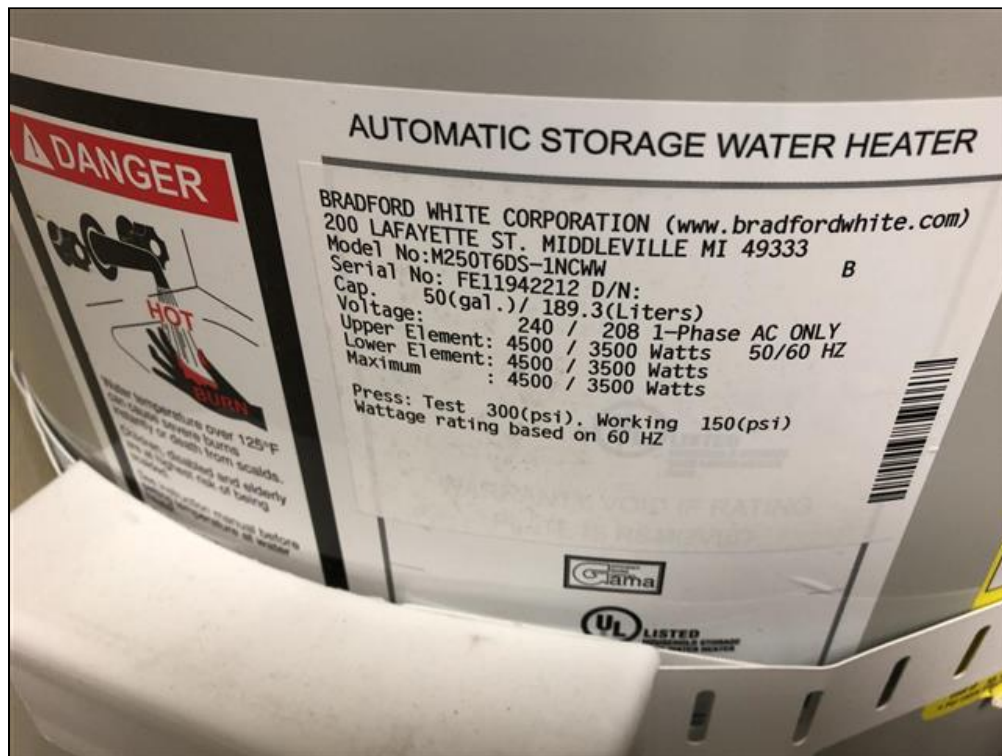
5.2 Item 1(Picture)

(1) **Repair:** The hot water heater re-circulating pump did not function at the time of inspection.

(2) **Improve:** A 50-gallon electric water heater appears to be the only source of hot water for this large commercial building; I recommend you consider increasing the size of this water heater to handle potential demand. The water heater appears to have been manufactured in 2009 and is, therefore, approaching its statistical expected life of 7-12 years; budgeting for replacement is advised.

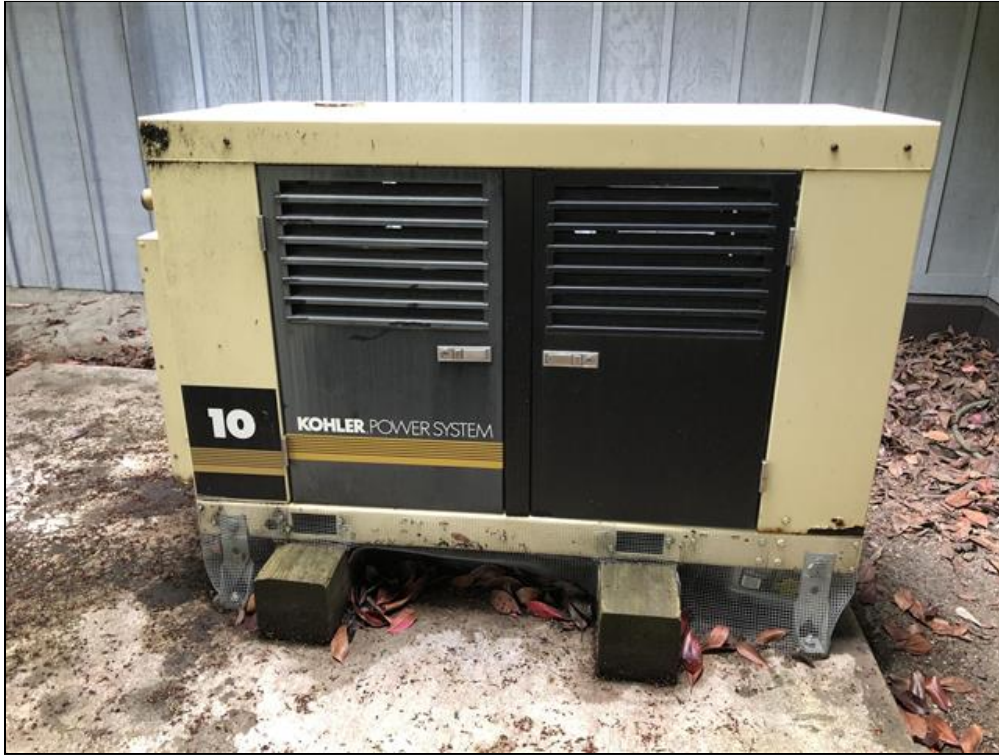
6.2 Item 1(Picture)

(1) **Repair / FYI:** Inspection of electric generator systems is beyond the scope of the home inspection. I recommend you inquire with the seller as to when the generator system was last serviced. Additionally, I recommend that you verify with the seller as to their routine maintenance protocol for the system. If this is of concern to you, I recommend further evaluation, service and repair as necessary by a qualified contractor.

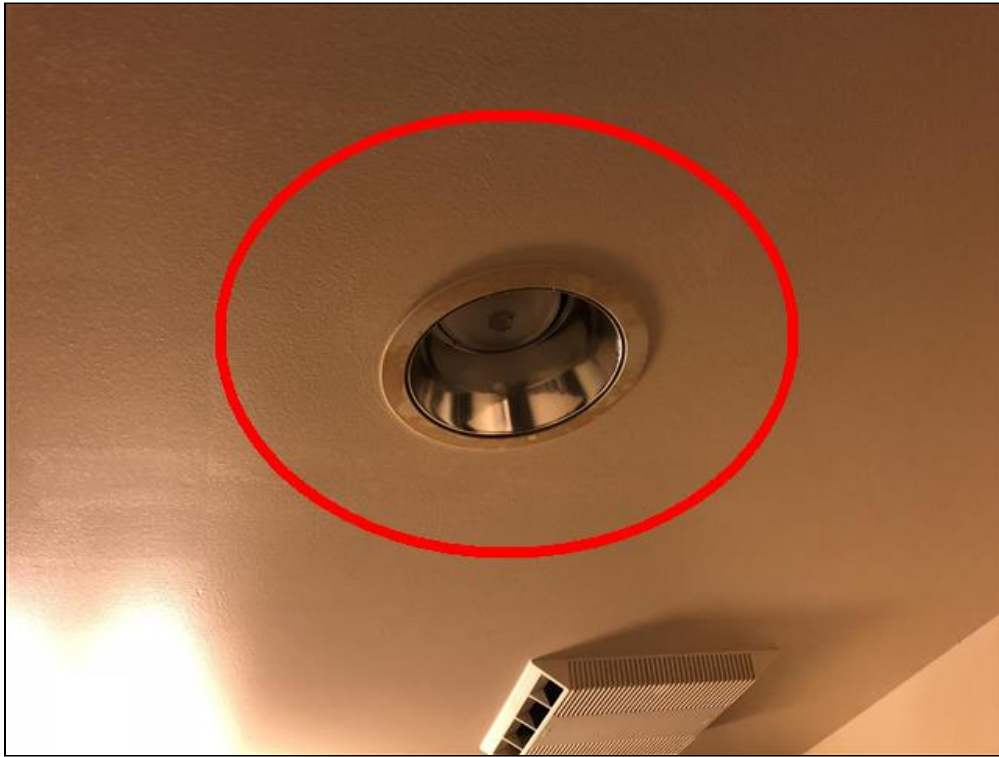
6.2 Item 2(Picture)

(2) **Repair:** A recessed light fixture in the main lobby bathroom did not function at the time of inspection. This is typically due to a blown or missing light bulb. I recommend installing a new light bulb to verify proper fixture function. See attached picture.

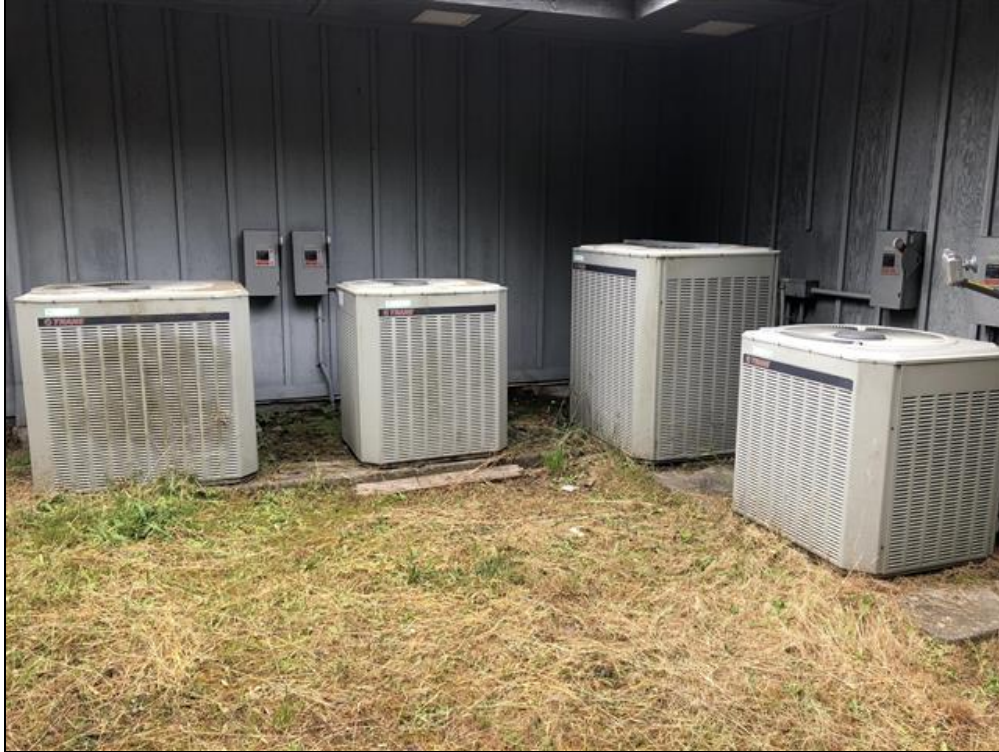
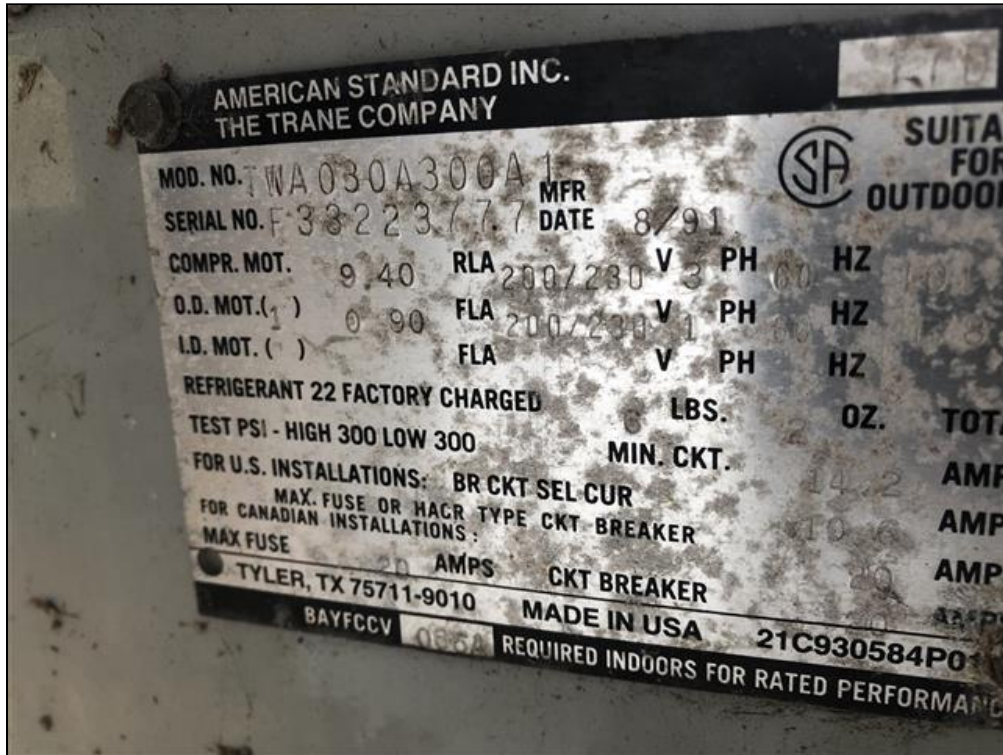
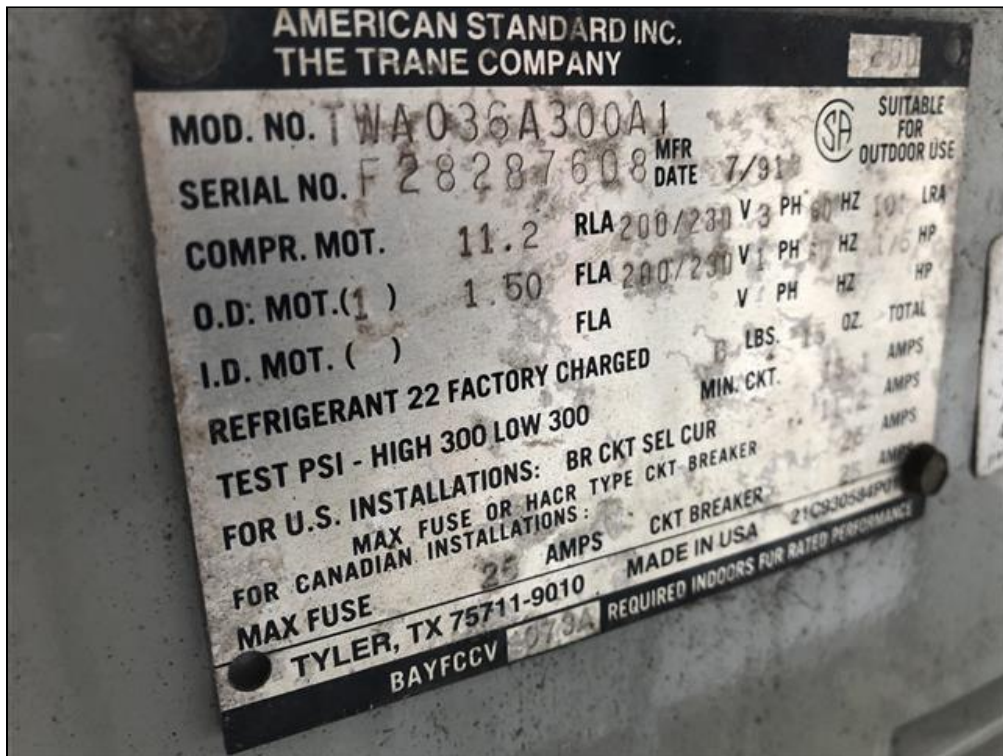
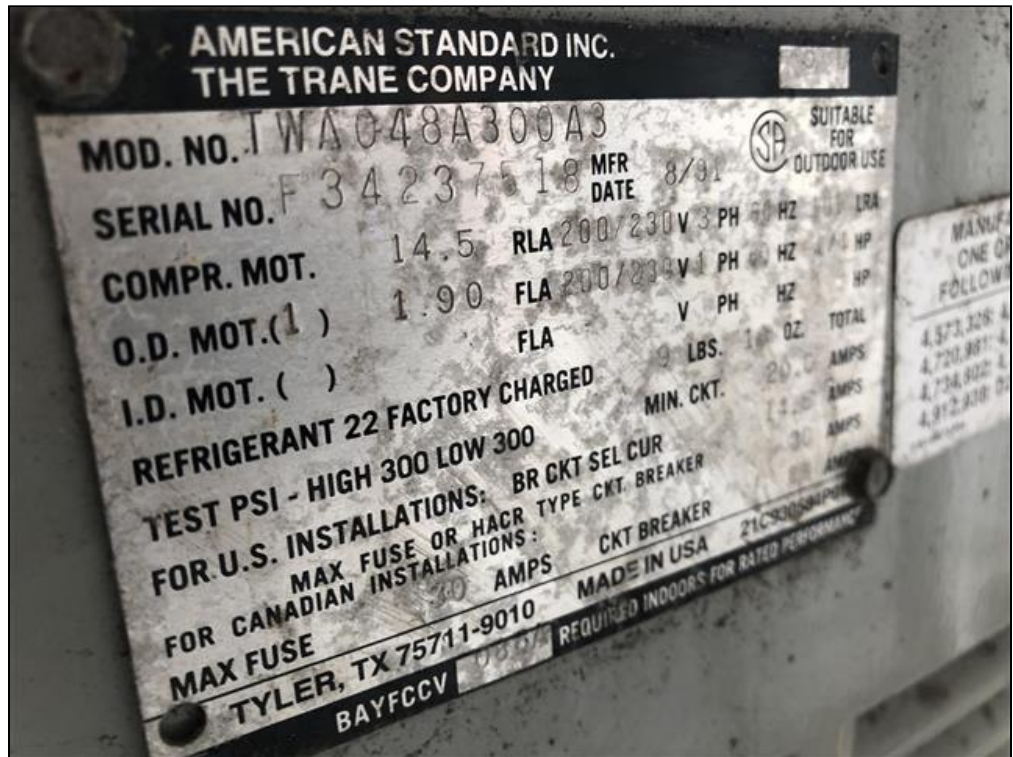
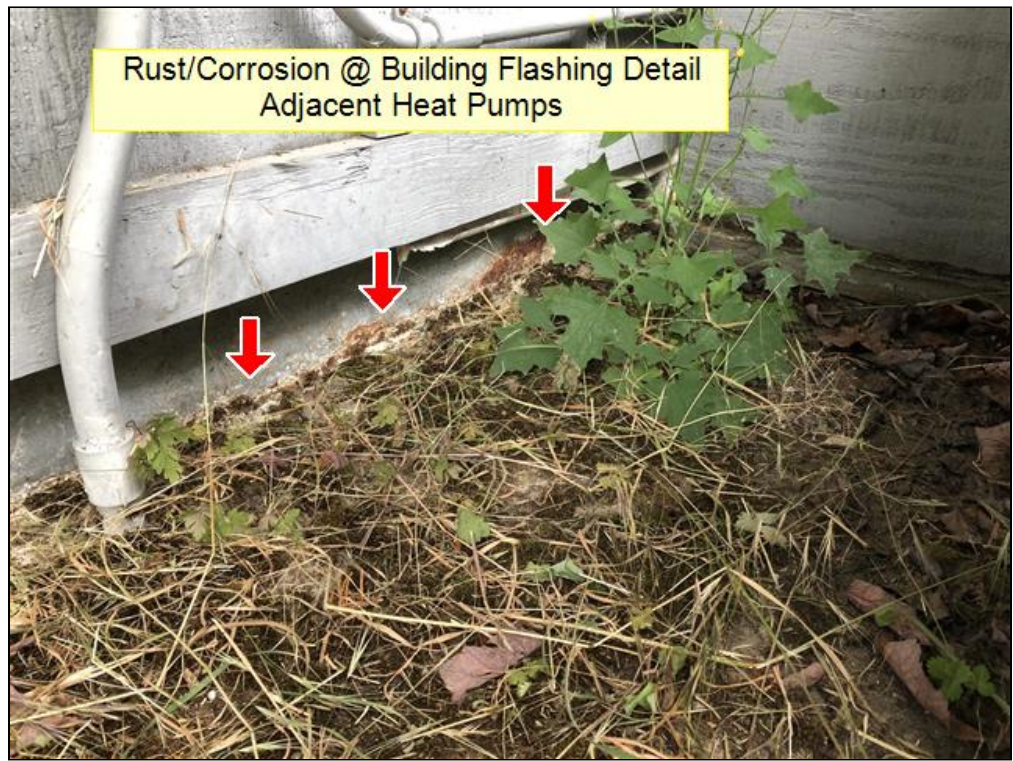
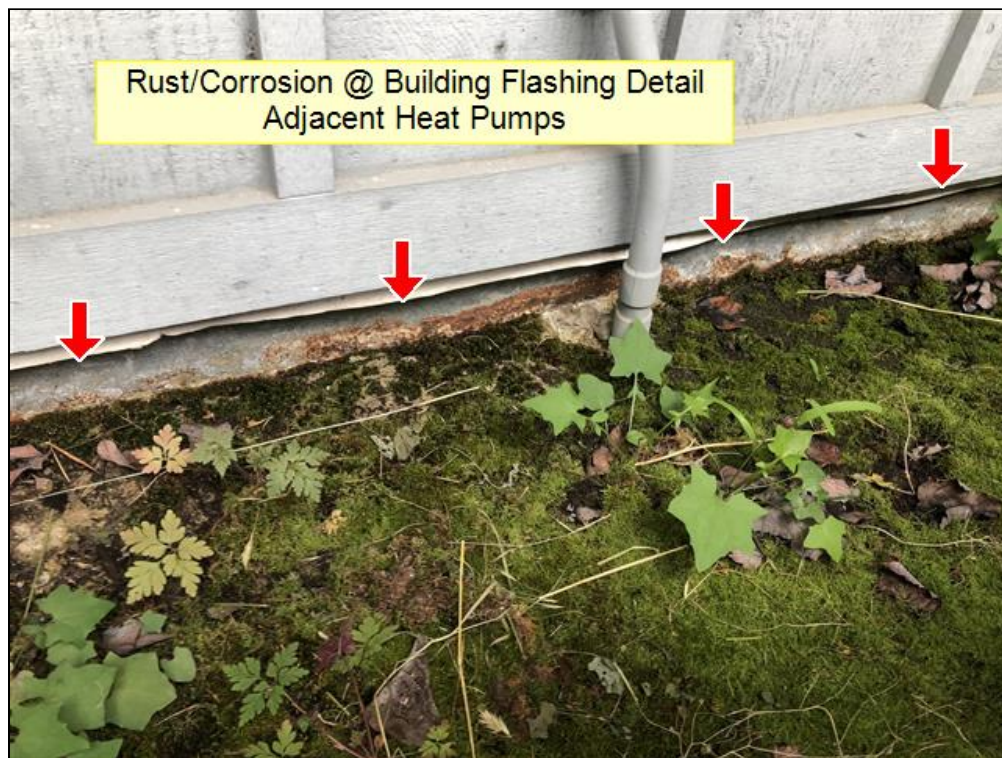
Major Issue: The four (4) American Standard heat pump heating/cooling systems, all original to the building (e.g., manufactured in 1991), are well beyond their statistical expected lives of 15-20 years. I highly recommend you have these appliances fully serviced prior to closing by a qualified HVAC contractor and that you budget for replacement, likely in the very near future. Additionally, concrete pads under some of the exterior compressor-condenser units appear sloped towards the building, where rusting/corroding metal flashing details were noted. See attached representative pictures, together with data plate information.

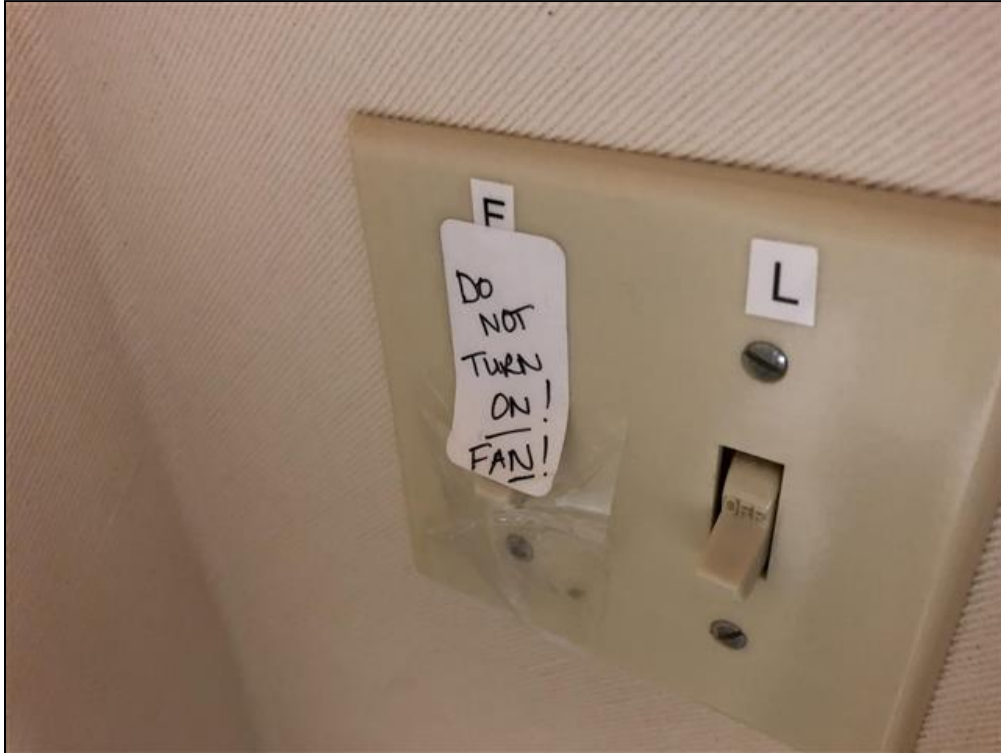
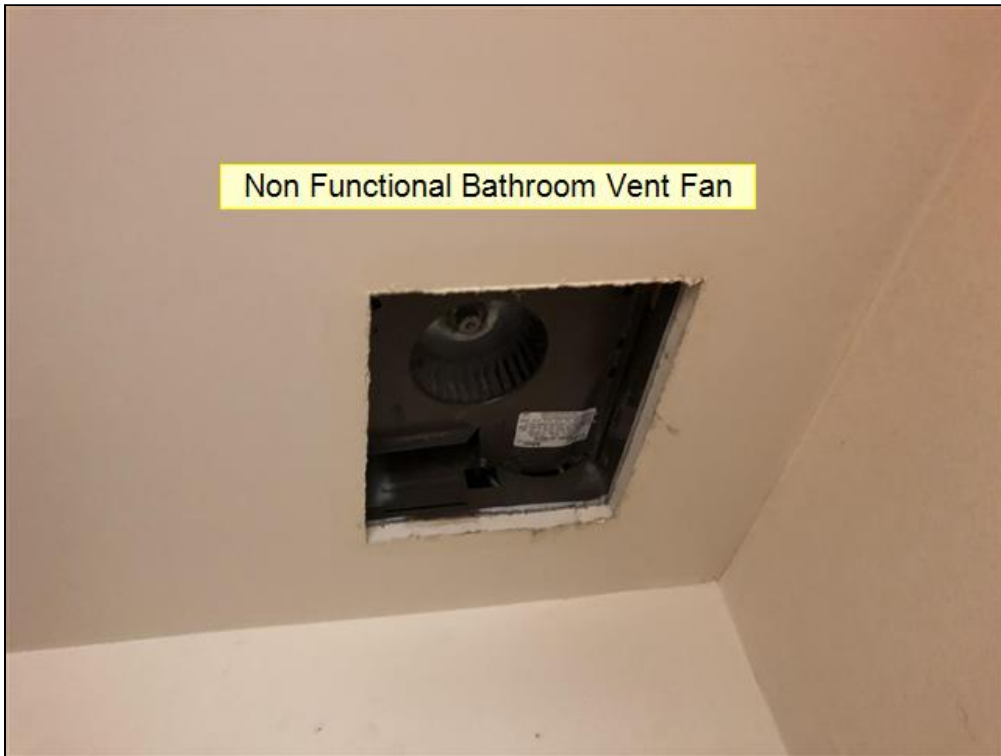
(1) **Repair:** The northern bathroom vent fan doesn't function; the switch has a sign indicating not to use. See attached pictures.

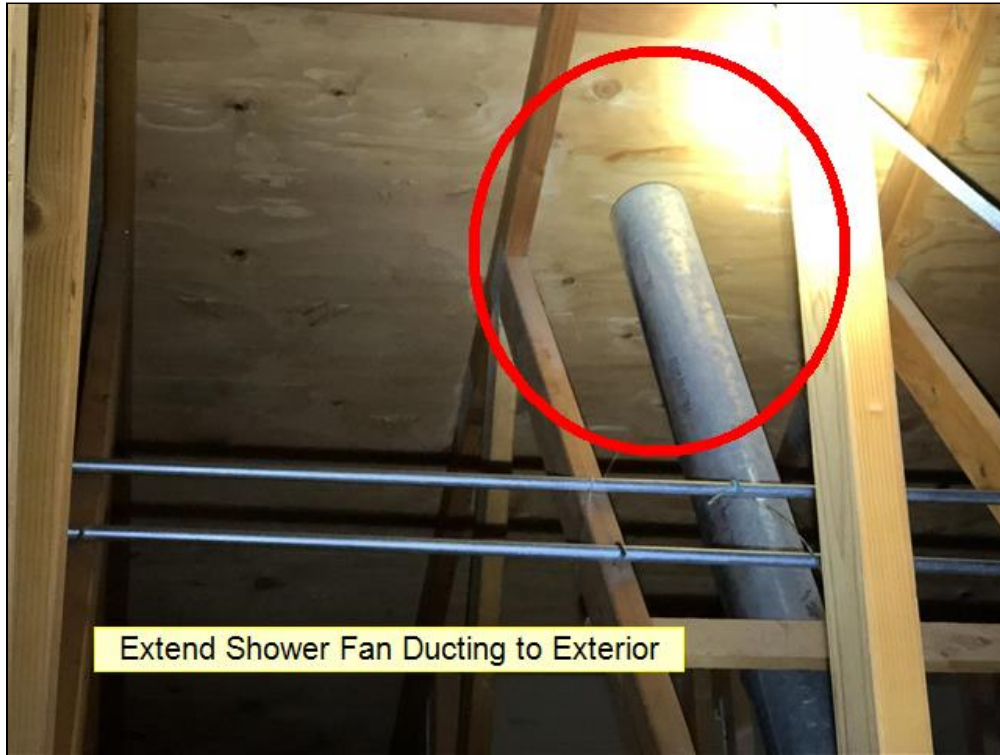
8.4 Item 3(Picture)

(2) **Repair:** The shower room vent fan ducting appears to discharge directly into the attic; while no signs of mold growth or elevated moisture were noted at the time of inspection, I recommend extending vent ducting to the exterior. See attached picture.
