Inspection Report

7 Deye Lane, Eastsound, WA 98245

Inspection Date: 7/7/2018
Report ID: 20180707-7-Deye-Lane

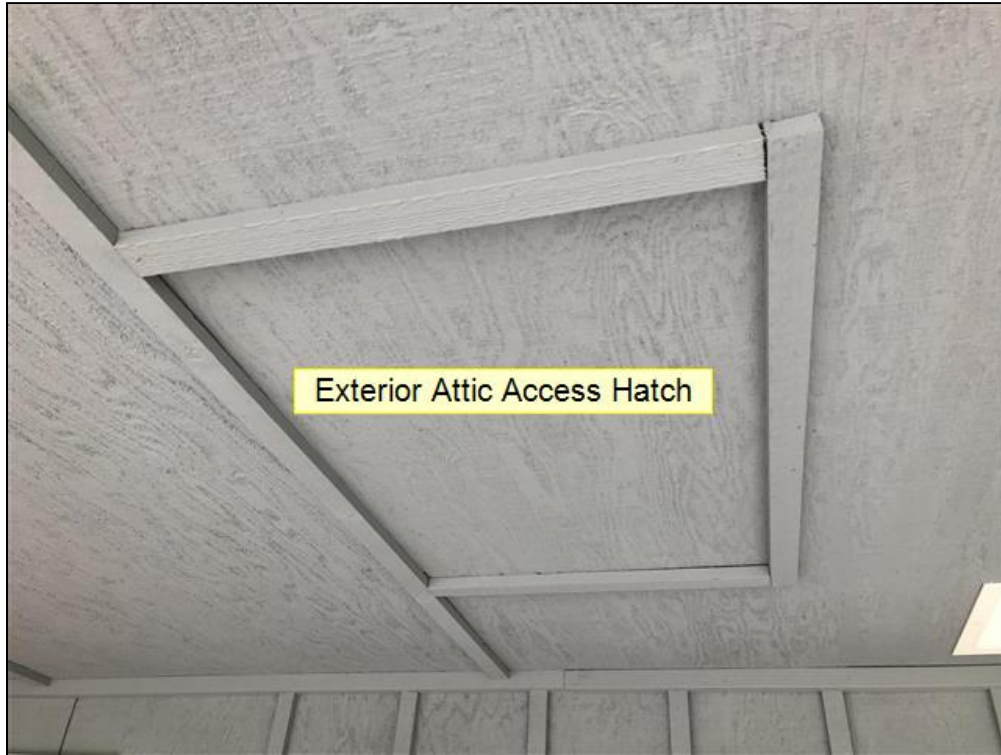
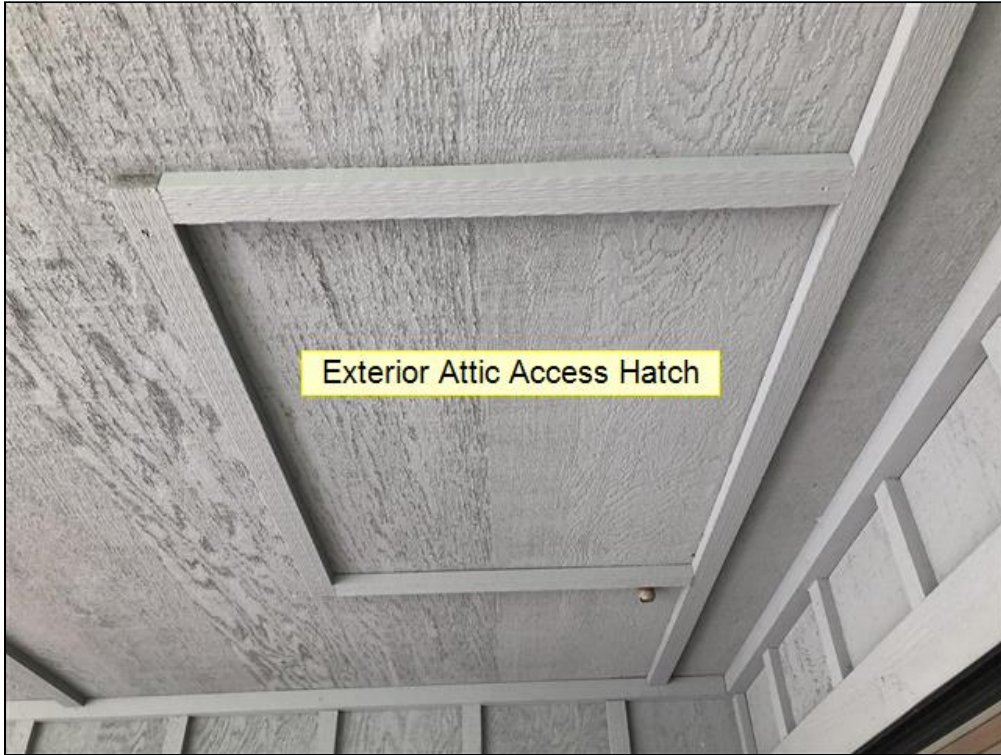
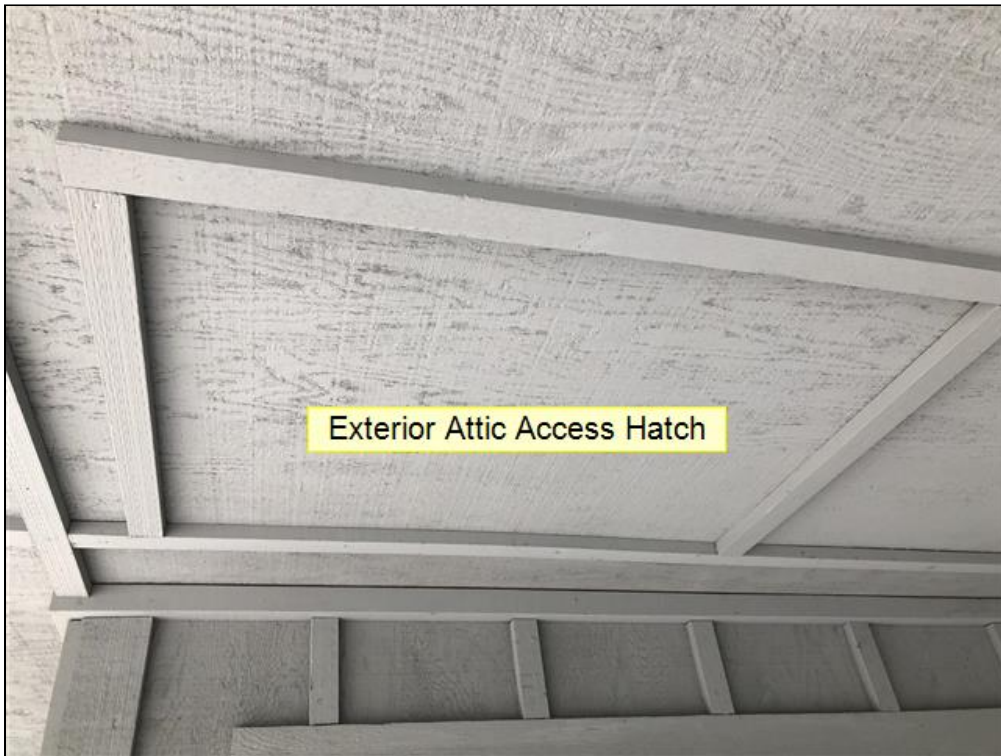
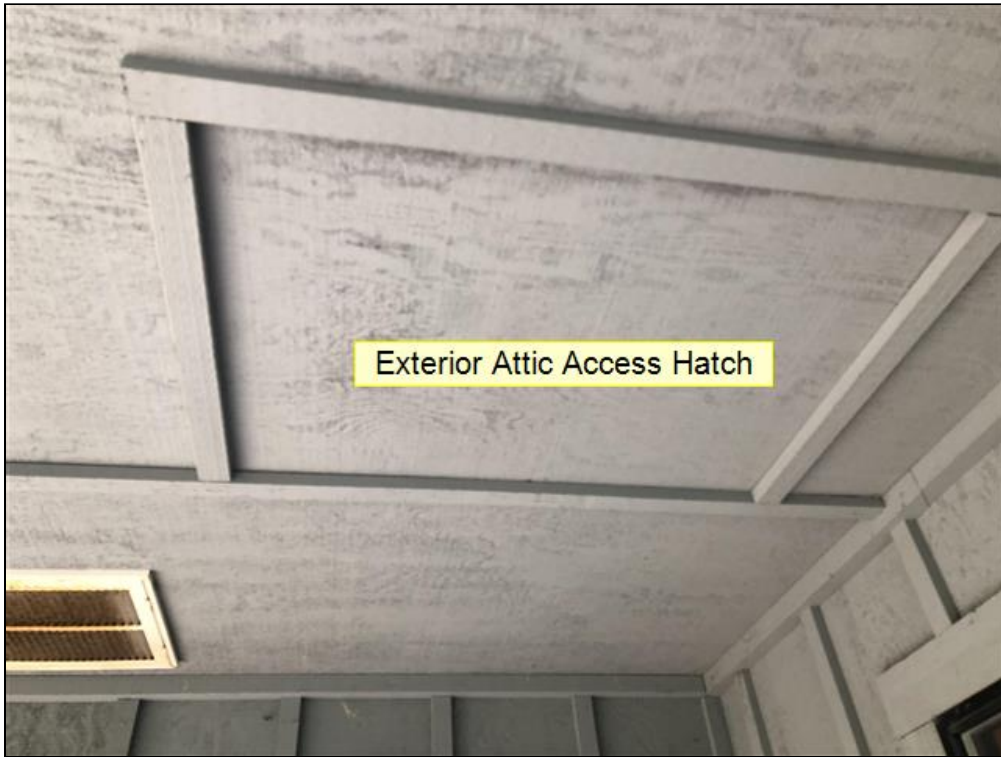
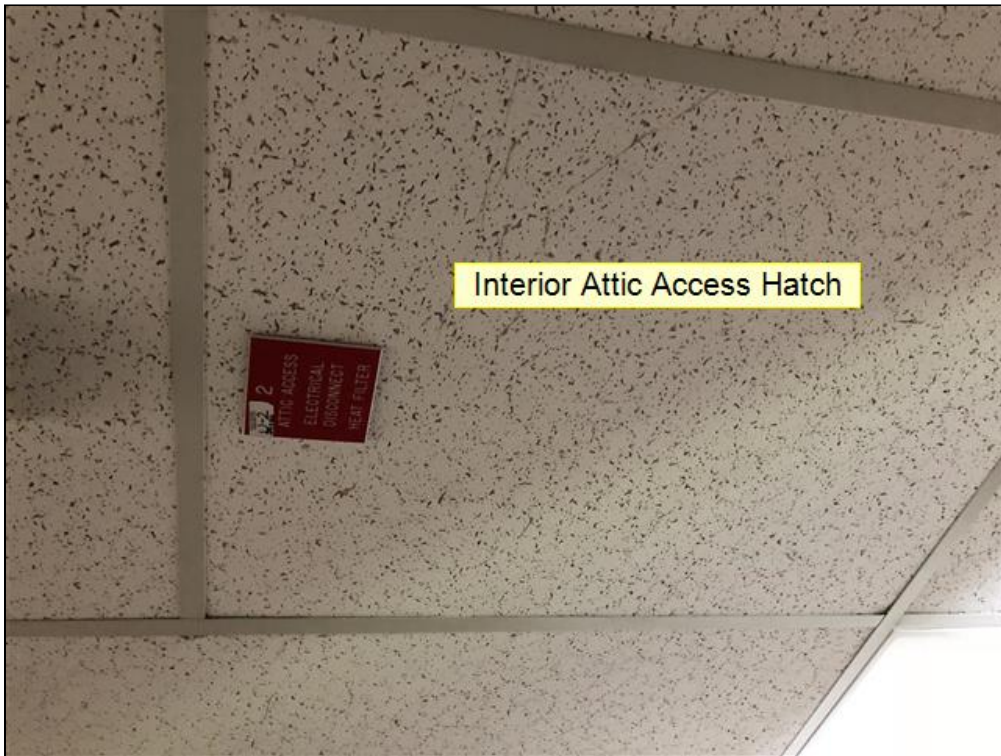
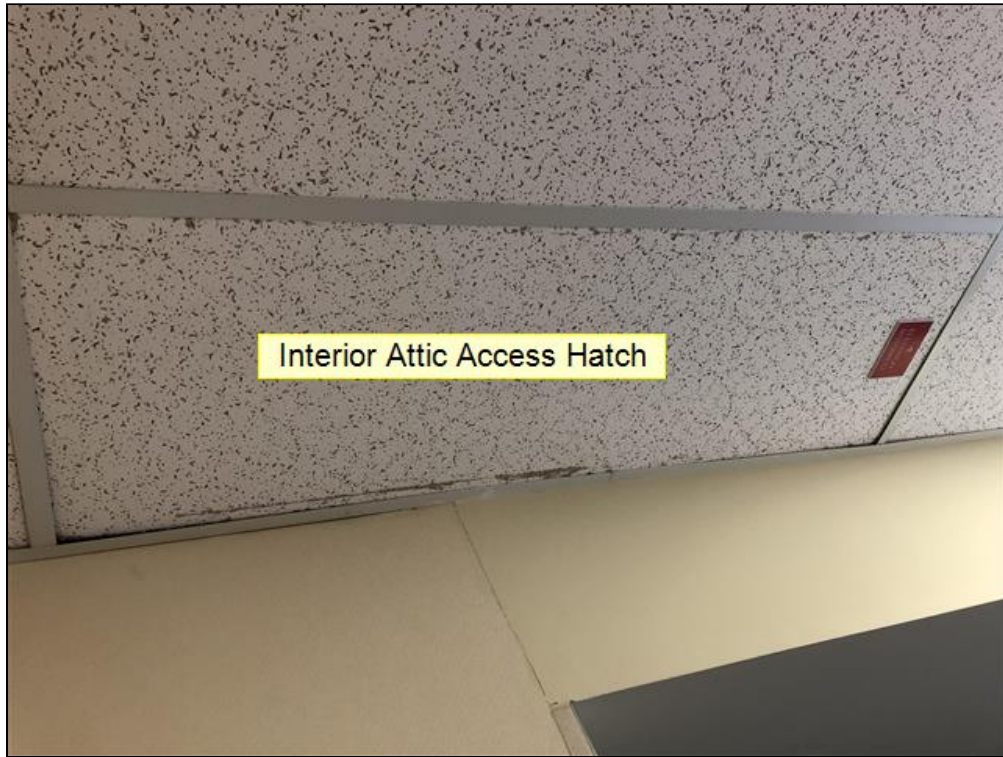
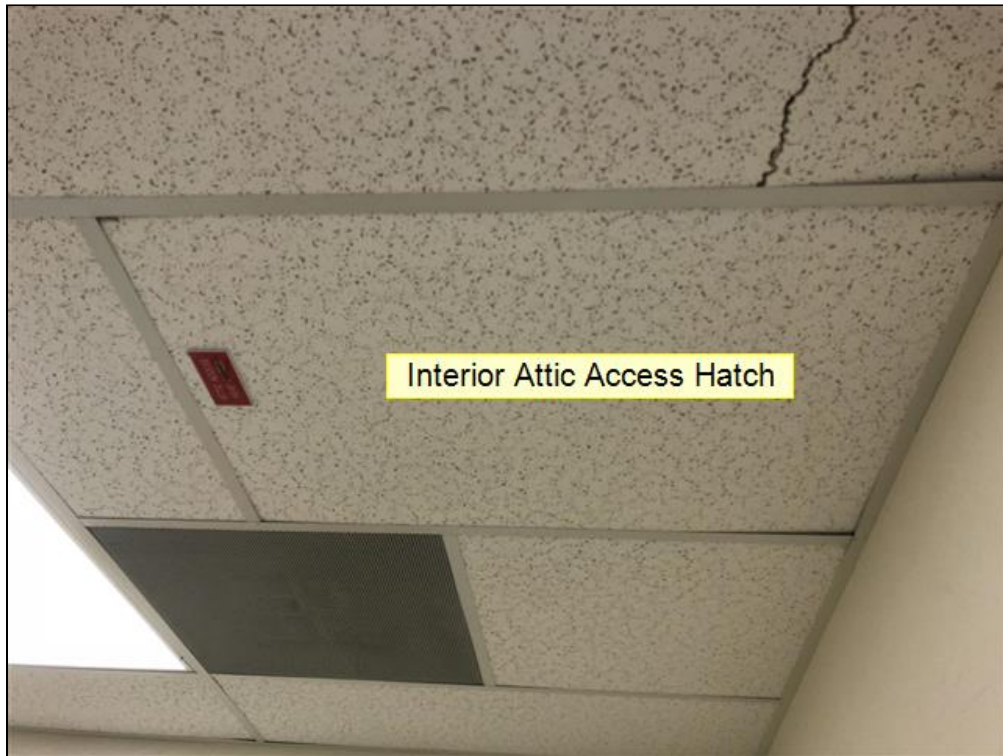
FYI: The attic is access from four (4) hatches at the exterior (three (3) at the southern exterior and one (1) at the eastern exterior). There is also an access hatch in the western locked storage room ceiling. Within the

interior, there are four hatches (all, except one, are labeled with red placards). The northern attic access hatch has pencil markings adjacent the ceiling tile indicating which panel to remove. See attached pictures.

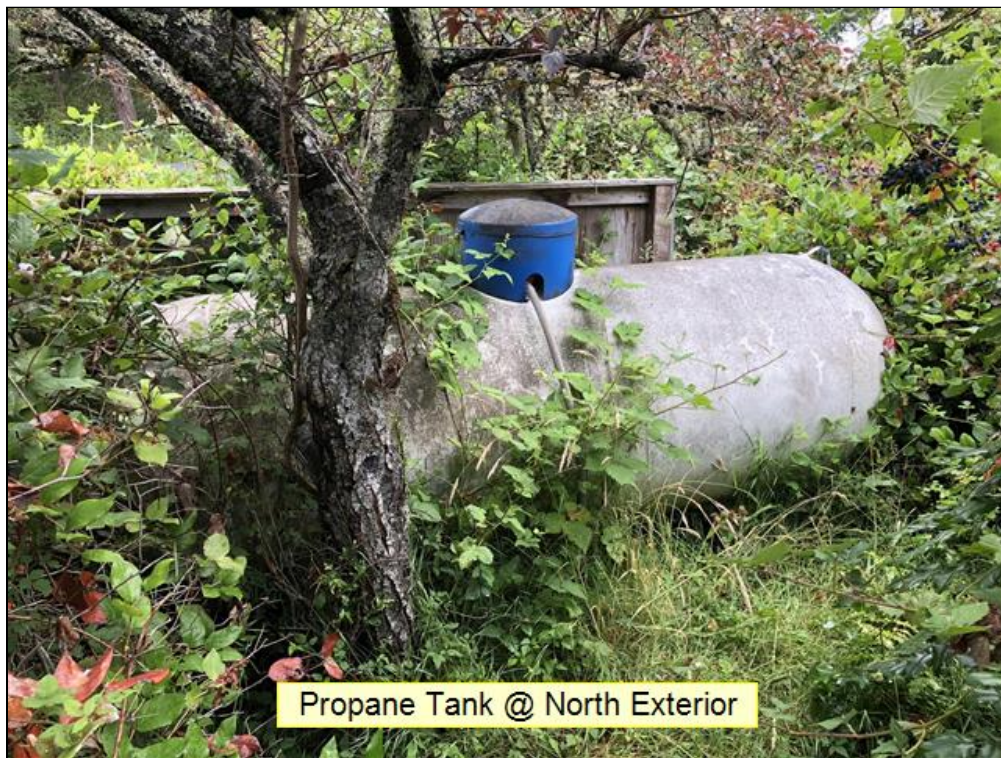
5.5 Item 1(Picture)

Propane Tank @ North Exterior. See attached picture.

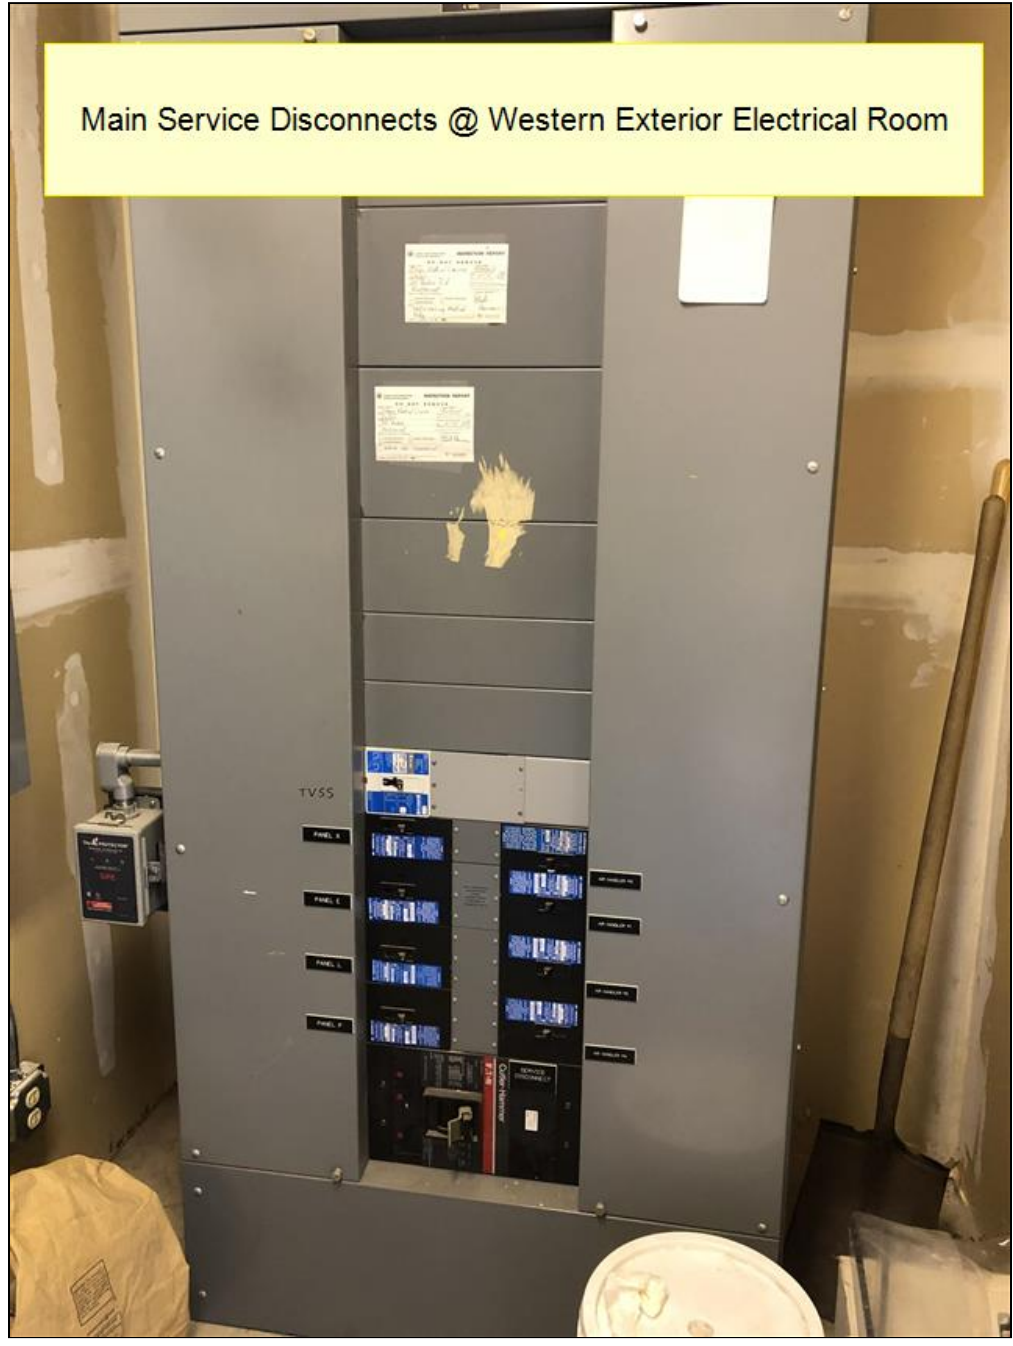
6.5 Item 1(Picture)

Main Panel and Subpanels in West Exterior Electrical Room AND Subpanel in XRAY Room. See attached pictures.
